Environmental Monitoring Systems Laboratory P.O. Box 93478 Las Vegas, NV 89193-3478 TS-PIC-90718 February 1990 Soms 88188004

AERIAL PHOTOGRAPHIC ANALYSIS OF GEORGE AIR FORCE BASE

Victorville, California

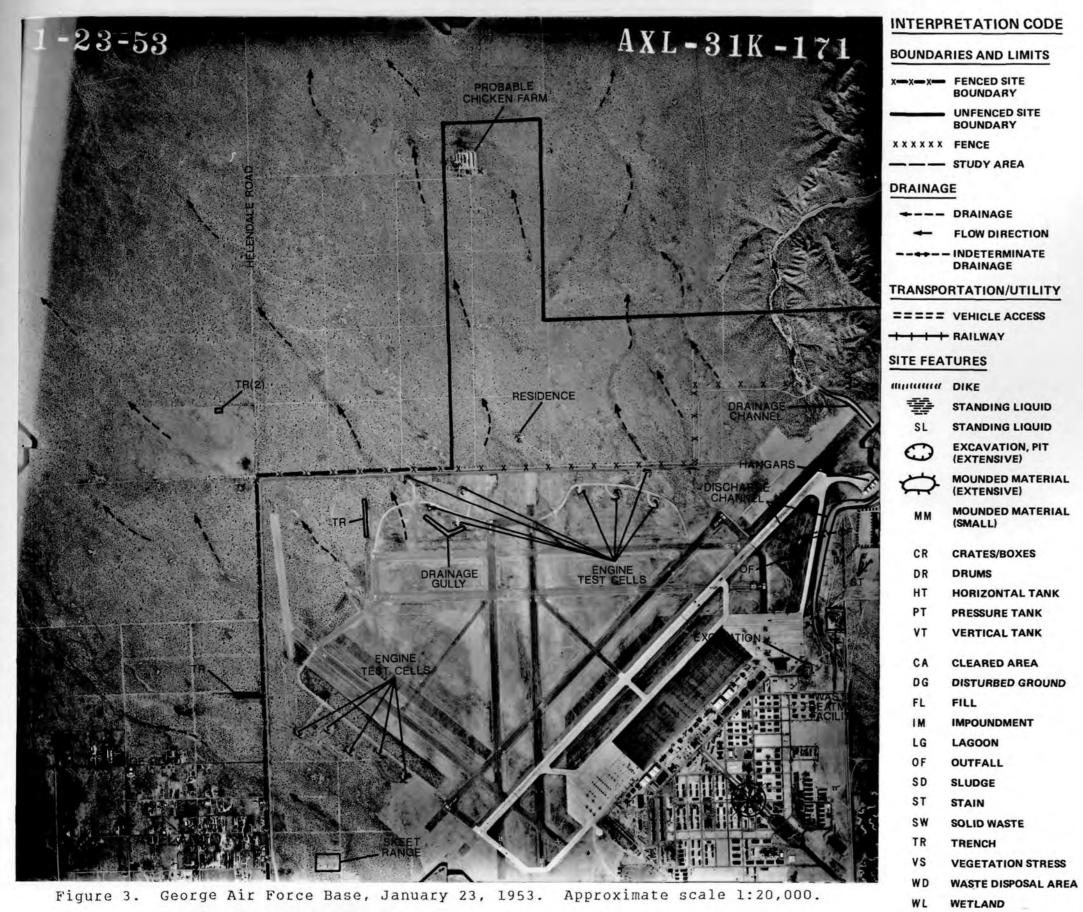
JANUARY 23, 1953 (FIGURE 3)

This photo shows the northwestern portion of George Air Force Base. Two small trenches are visible in the desert area, outside the northwest corner of the base. These trenches are empty and show no signs of waste disposal activity. A larger trench is noted outside the western perimeter fence. This trench also shows no sign of disposal activity. One trench is noted in the northwest corner of the base. It appears to be drainage related. No disposal activity is visible at this trench. On the eastern side of the base runways is a small waste treatment facility. A manmade drainage channel has been constructed west of this facility and carries drainage to the north, around the end of the runway, into an unidentified creek which empties into the Mojave River. No outfall is noted from the waste treatment facility into this channel, but it is assumed that one is present. A small excavation is noted southwest of the treatment facility; this appears construction related rather than a disposal site. Spill stains are visible on aircraft parking ramps and near maintenance areas.

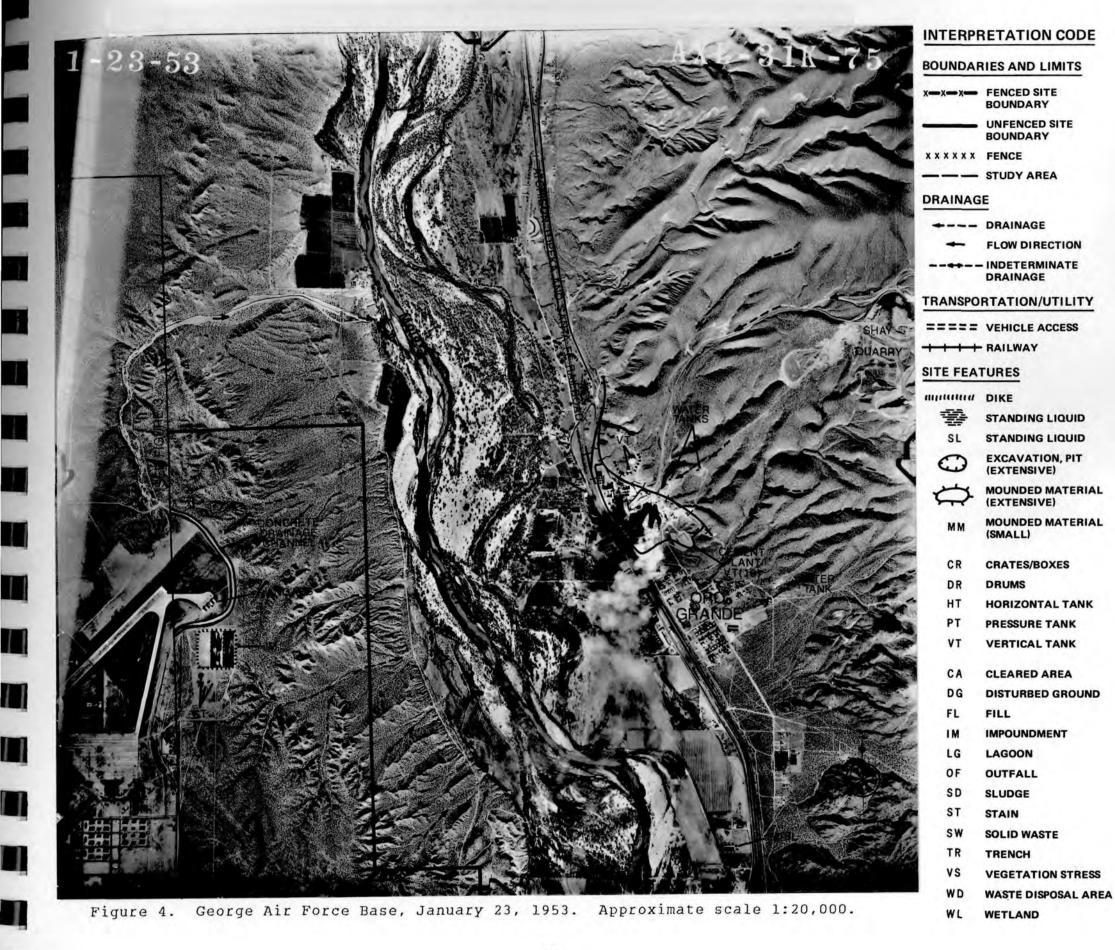
JANUARY 23, 1953 (FIGURE 4)

This photo shows the northeastern portion of George Air Force Base. Three percolation ponds are noted. These ponds are probably associated with the waste treatment facility to the south (Figure 3). The ponds are presently empty; two of the ponds have heavily stained floors, while the third is clean. The ponds are unlined. Staining is also noted in an area just to the south of these ponds.

East of the air base, across the Mojave River is the town of Oro Grande. A large cement plant with 19 uncontained vertical tanks is noted north of the town. The tanks probably contain dry products. North of the plant are two vertical tanks with containment berms on the downslope side. The two impoundments between the air base and the railroad are probably reservoirs.

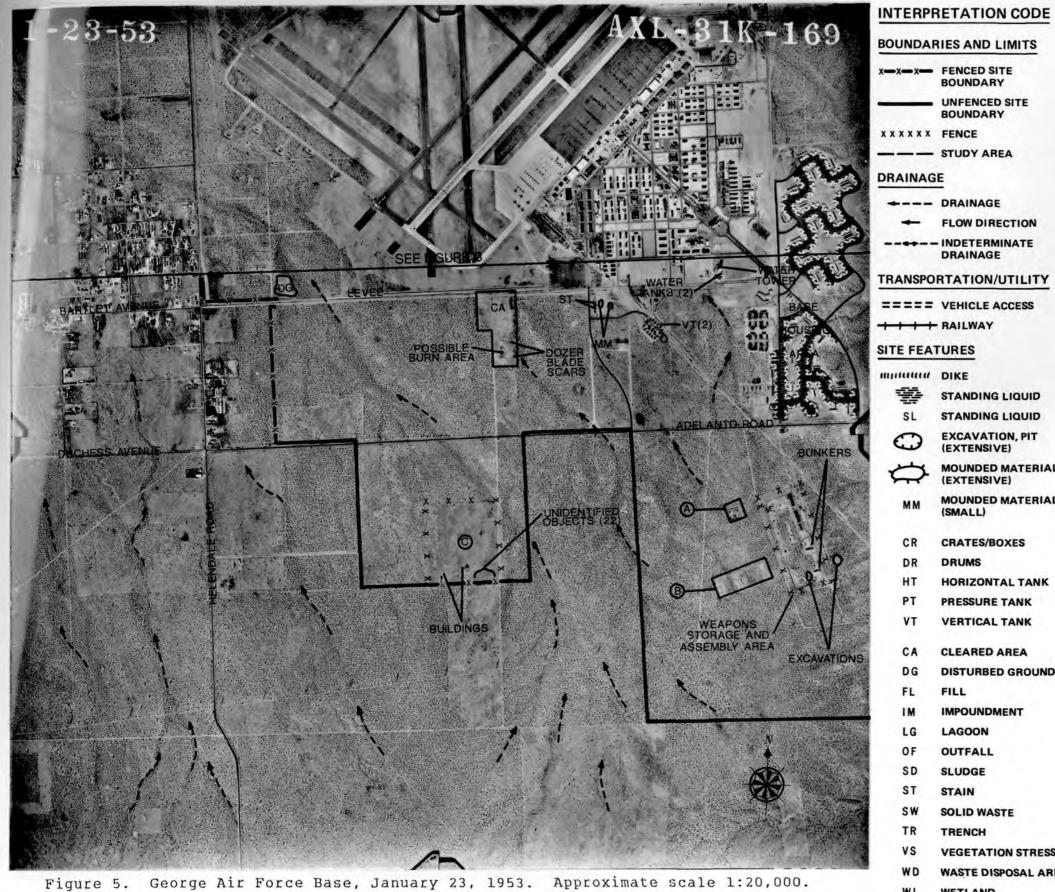
JANUARY 23, 1953 (FIGURE 5)

This photo shows the southwest portion of George Air Force Base. Directly south of the main north/south runways is an area which has had the sagebrush and other vegetation removed. The southern portion of the area shows discolored ground, which could possibly be an old burn area, and scars from recent bulldozer activity. East of this area are two stains and some unidentified mounded material. Again, the stains appear to be burn stains. Two, well-contained vertical storage tanks are noted east of this area. South of the base housing area is a separately secured area which appears to be a weapons storage and assembly area. Two earth-covered bunkers, three probable assembly buildings, and four unidentified smaller buildings are noted within the secured area. An excavation is noted in the southern portion of the area and is probably construction related. Annotations A and B, west of this area, are probably assembly related. Annotation A has two drive-thru revetted areas which are presently storing unidentified objects. Annotation B has three drive-thru revetted areas. Annotation C is an unidentified secured, cleared area. Two buildings and 22 unidentified objects (possibly vehicles) are noted within the area.

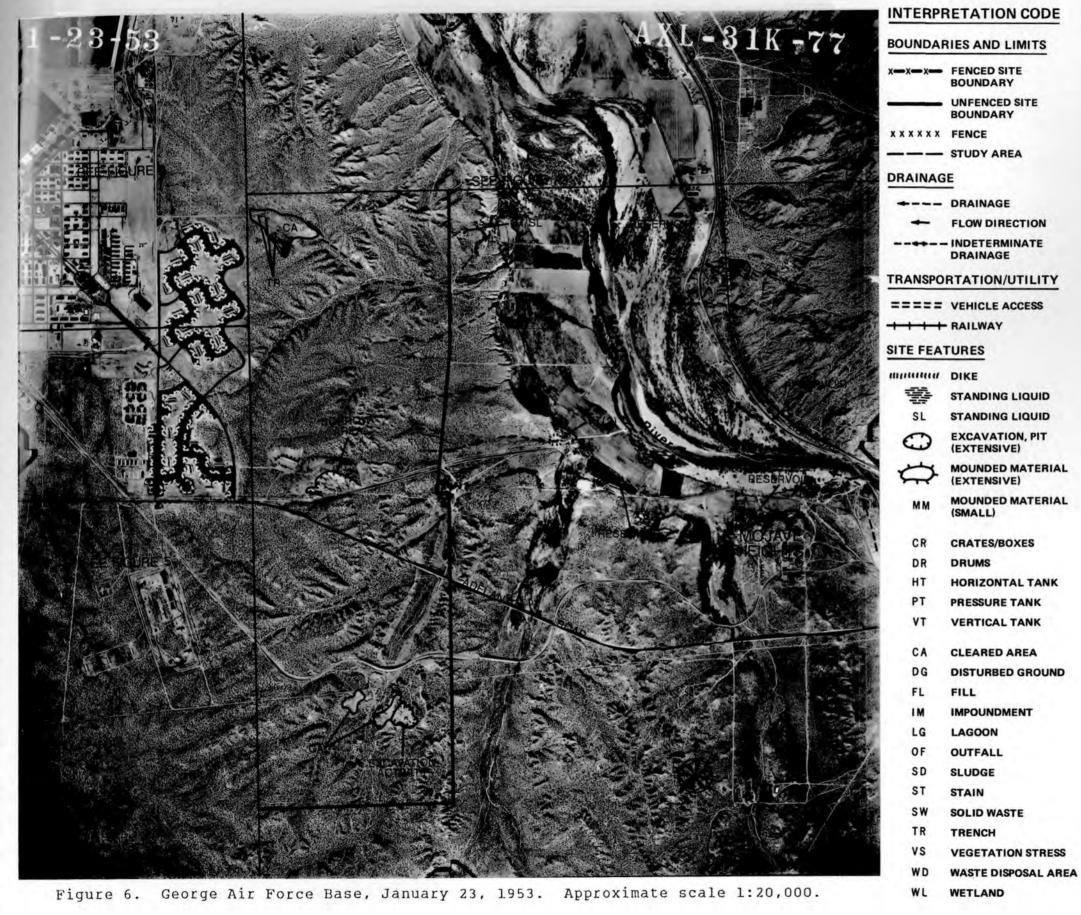
JANUARY 23, 1953 (FIGURE 6)

This photo shows the southeastern portion of George Air Force Base. The only item of environmental significance, within the base area shown, is a cleared area with three trench-like excavations. The westernmost of these excavations contains possible waste material (trash); the remaining two appear empty. Unidentified vehicular activity is visible within this area. The small impoundment noted northeast of the base perimeter appears to contain water. A borrow area is noted along the southern perimeter of the base. An earthen berm is located in a cleared area west of the borrow area. Its purpose is unknown. South of the borrow area and Adelanto Road is an area of extraction activity and two cleared areas. Activity within these areas is unidentified.

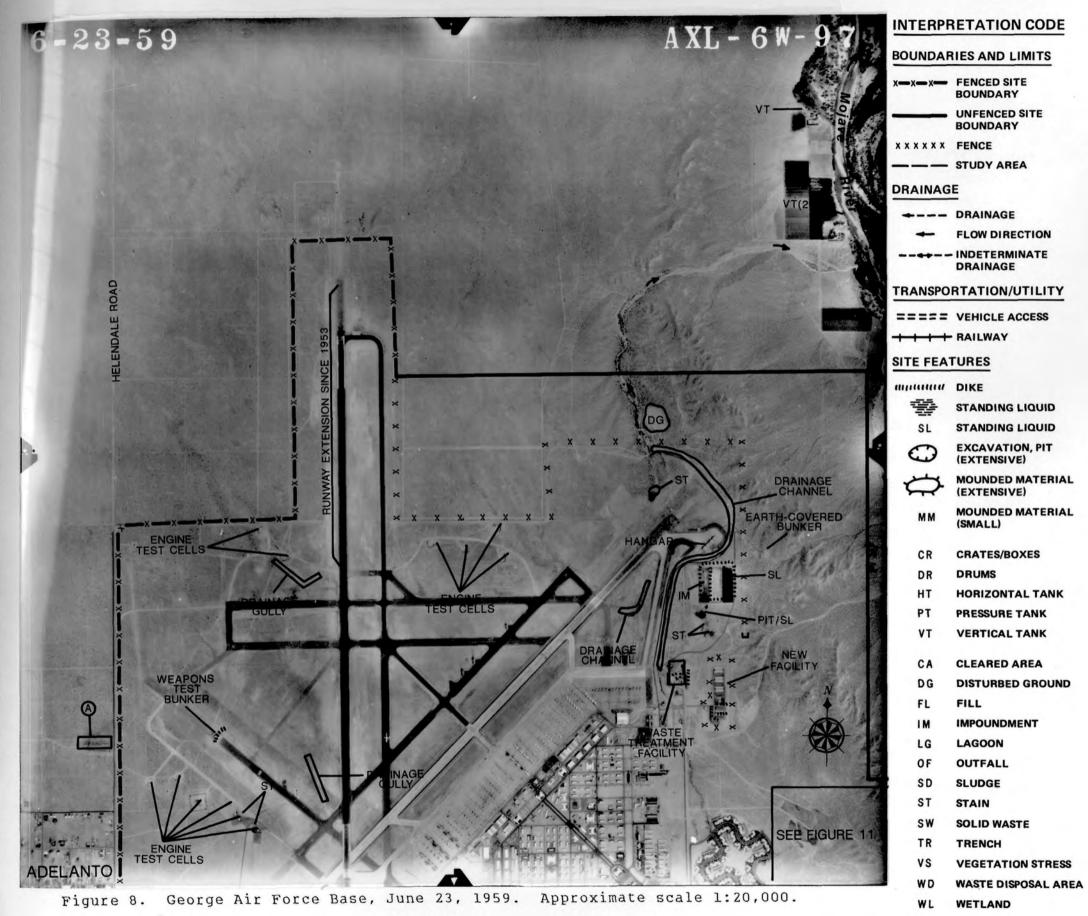
JUNE 23, 1959 (FIGURE 8)

This photo shows the northwestern portion of George Air Force Base. There has been little change of environmental significance in this portion of the base since the 1953 photo coverage (Figure 3). The main north/south runways have been extended to the north. A new, probable weapons related, facility has been constructed east of the waste treatment facility. The waste treatment facility's percolation ponds, located north of this facility, remain unchanged with the exception that the easternmost pond now contains liquid. The center pond also appears cleaner than previously noted. Staining and standing liquid are noted south of the ponds. This area has been identified as a fire training area. The trench noted in 1953 in the northwest corner of the base is no longer visible. At Annotation A, outside the western perimeter fence, is the location of a trench noted in 1953. The poor resolution of this photo denies confirmation as to whether this trench still exists. Staining is still visible within aircraft parking and maintenance areas.

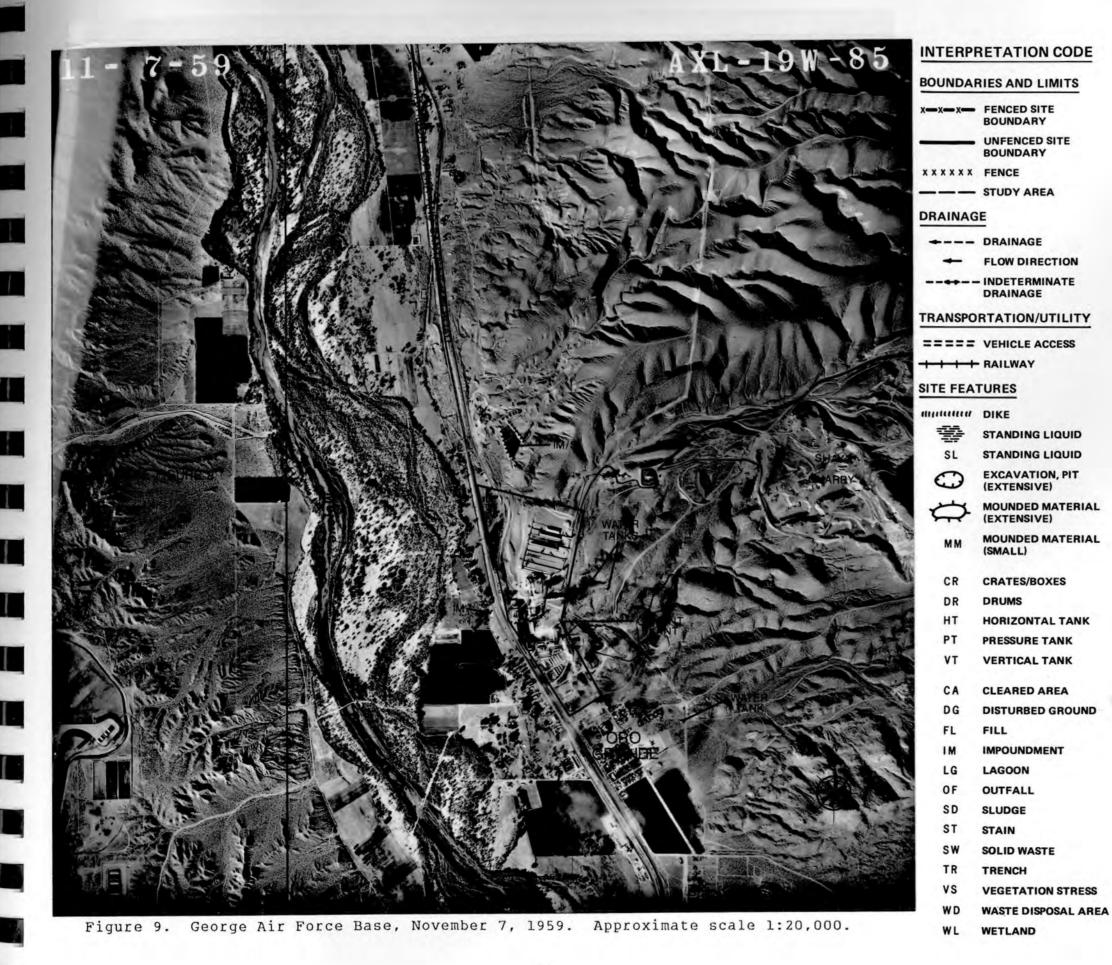
NOVEMBER 7, 1959 (FIGURE 9)

This photo shows that little change has occurred in the northeastern portion of George Air Force Base since the 1953 photo coverage (Figure 4). The cement plant, north of Oro Grande has undergone considerable expansion as has the Shay Quarry to the east.

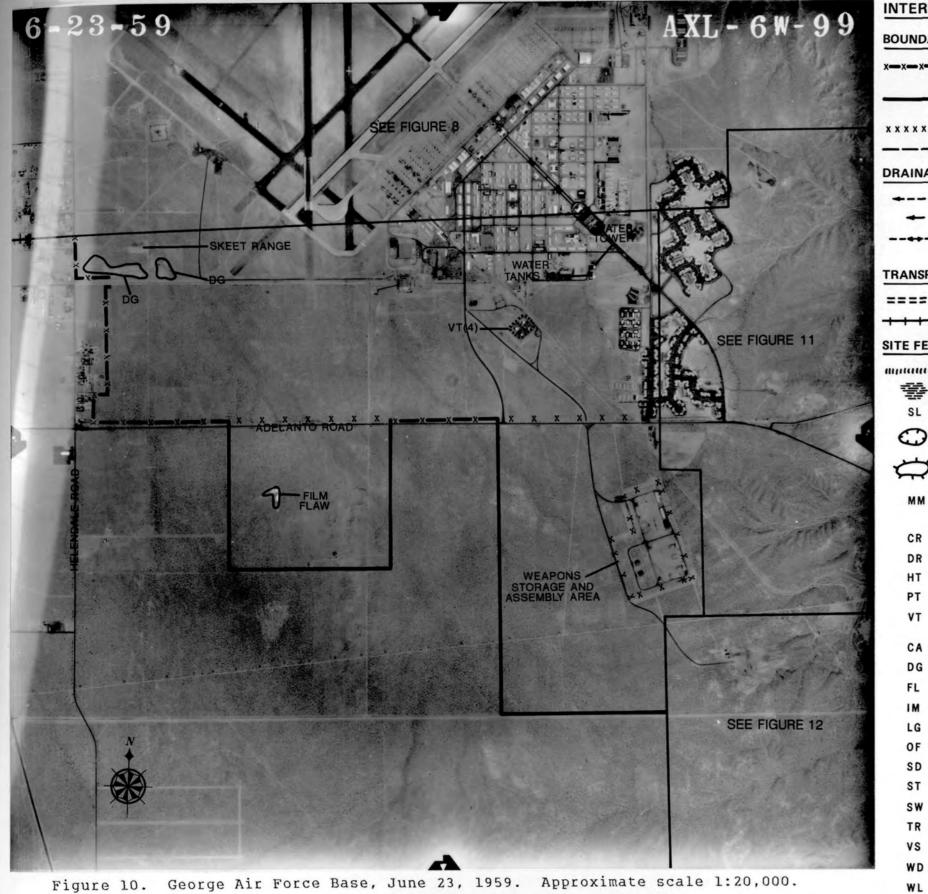
JUNE 23, 1959 (FIGURE 10)

This photo shows the southwest portion of George Air Force Base. The only changes noted since the 1953 photo coverage (Figure 5) are an additional two well-contained, vertical tanks, and an enlargement of the weapons storage and assembly area. Three small earth-covered bunkers and a drive-thru revetment have been added to the area. Annotations A, B, and C, noted on the 1953 photo coverage, are no longer active.

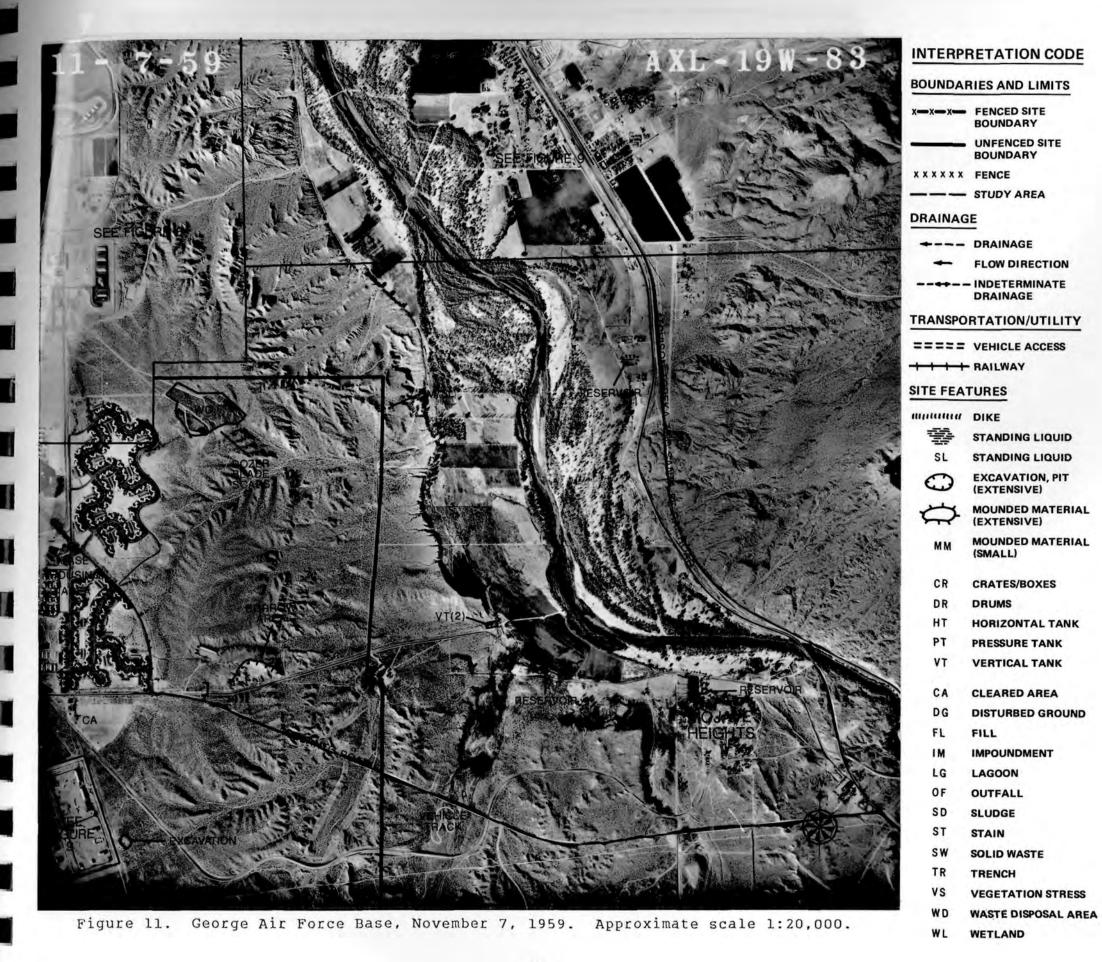
NOVEMBER 7, 1959 (FIGURE 11)

This photo shows the southeast portion of George Air Force Base. The major environmentally significant change to this area since the 1953 photo coverage (Figure 6) is in the area northeast of the base housing area. The 1953 photography showed a cleared area with three trenches; one possibly containing waste material. This area is presently covered with hundreds of dump-truck-size mounds of unidentified material. The material appears to be trash. Dirt roads lead both from the housing area and the operational portion of the base. No other significant changes are noted in this area since 1953.

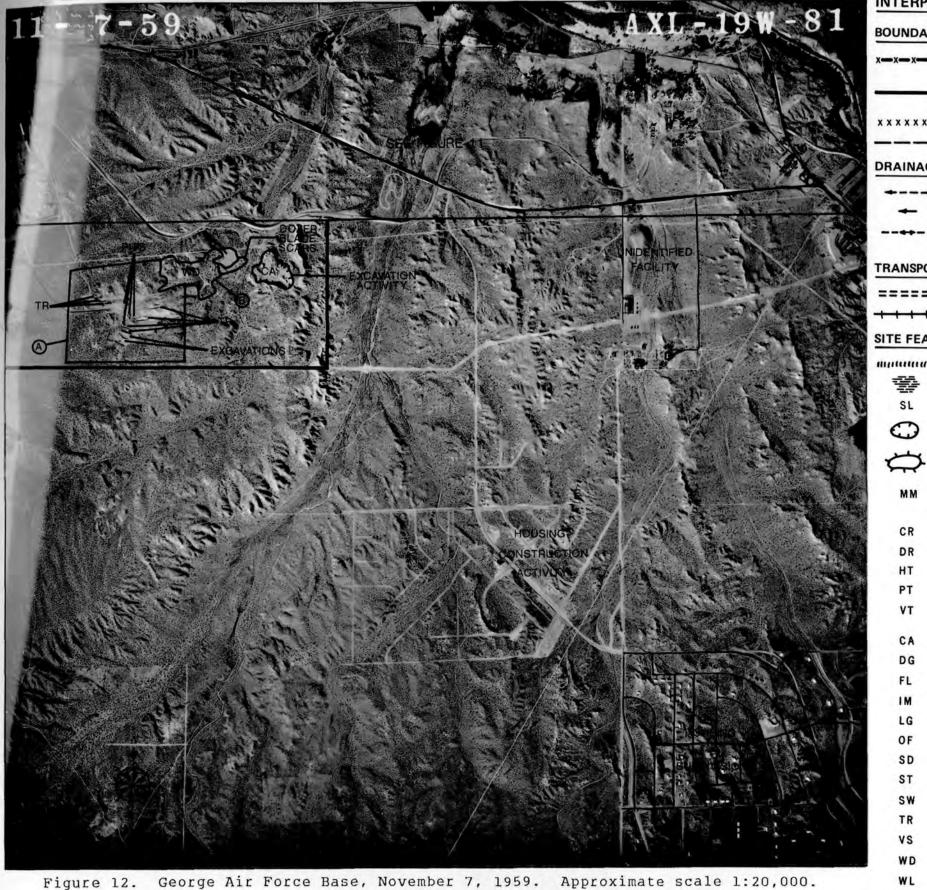
NOVEMBER 7, 1959 (FIGURE 12)

This photo shows a new waste disposal area southeast of the weapons storage and assembly area. The 1953 photo coverage (Figure 6) showed two cleared areas and an area of extraction activity, but no active waste dumping in this area. Visible within Annotation A are at least seven trenches, four pits, and two excavations. Two of the three trenches on the west side of this area contain unidentified material, as do the four pits. The two excavations and remaining four trenches are empty. At Annotation B, numerous dump-truck-size mounds of unidentifiable material have been deposited. Dozer blade scars are visible within this area.

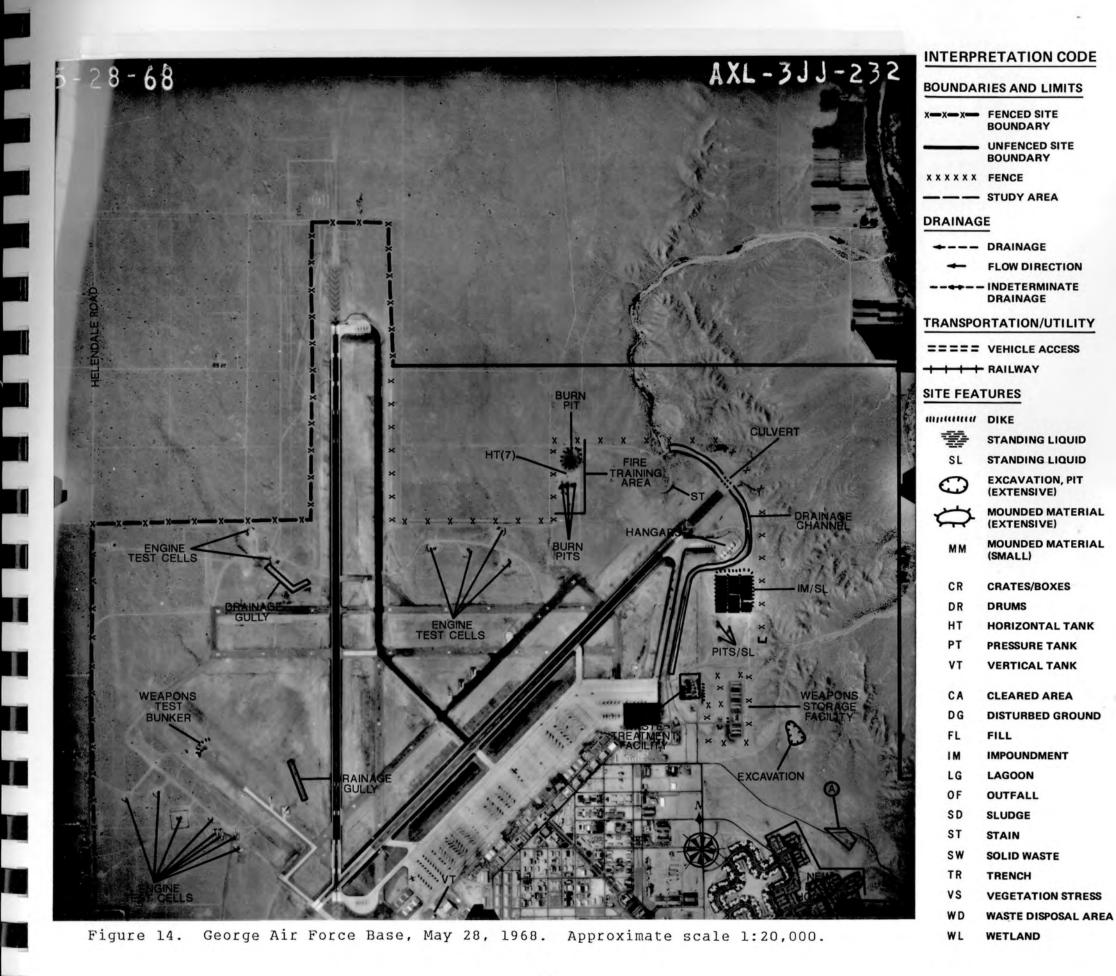
MAY 28, 1968 (FIGURE 14)

This photo shows that a few changes have occurred in the northwestern portion of George Air Force Base since the 1959 photo coverage (Figure 8). The waste treatment facility's percolation ponds remain, but their configuration has been altered so that there are now five ponds instead of three. All the ponds contain liquid waste. The fire training area south of the ponds has three pits containing an unidentified liquid. A new fire training area has been constructed in the northeast portion of the base, north of the runways. This area has four burn pits, one of which has a low earthen berm surrounding it. Seven horizontal tanks are also noted in the area. The base housing area, in the southeast corner of the photo, has expanded. Numerous dump-truck-sized mounds of unidentifiable material are still visible at Annotation A though fewer than the number seen on the 1959 photo coverage (Figure 11). Staining is still visible in all aircraft parking and maintenance areas.

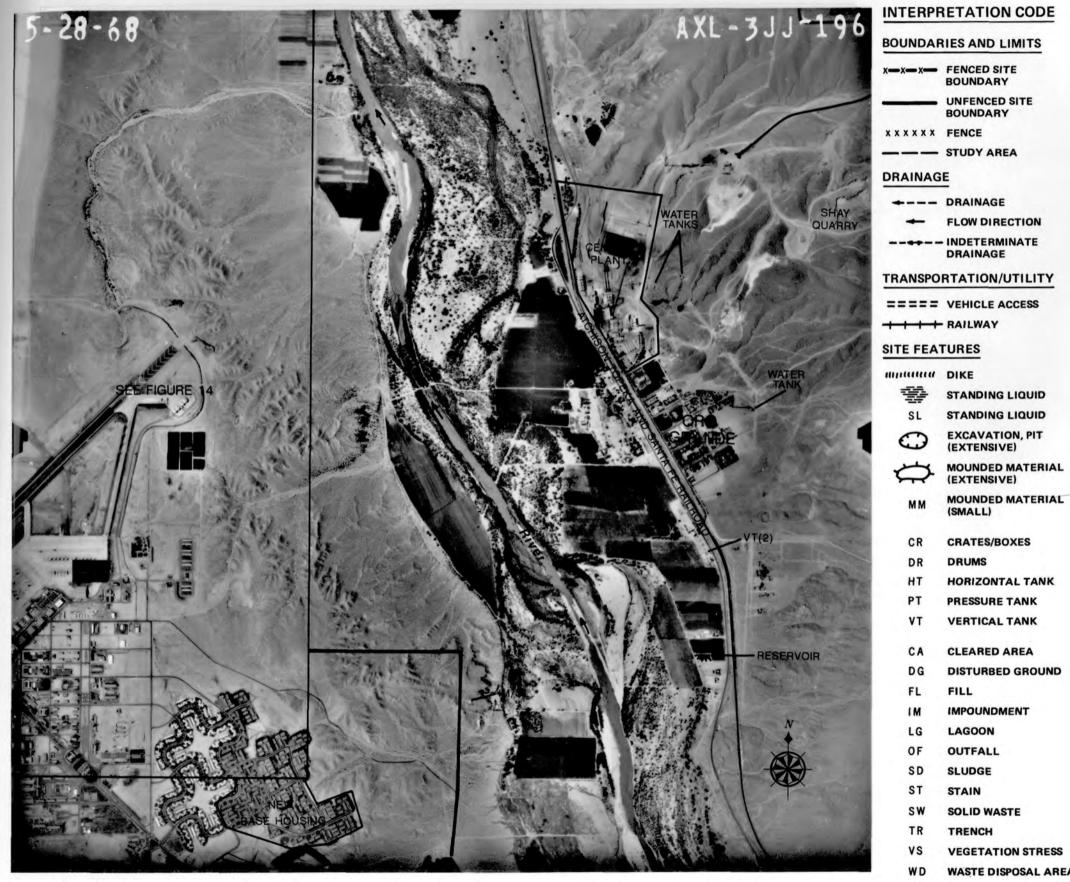
Figure 15. George Air Force Base, May 28, 1968. Approximate scale 1:20,000.

This photo shows the northeastern portion of George Air Force Base. Little change has occurred in this portion of the base since the 1959 photo coverage (Figure 11) with the exception of the base housing expansion.

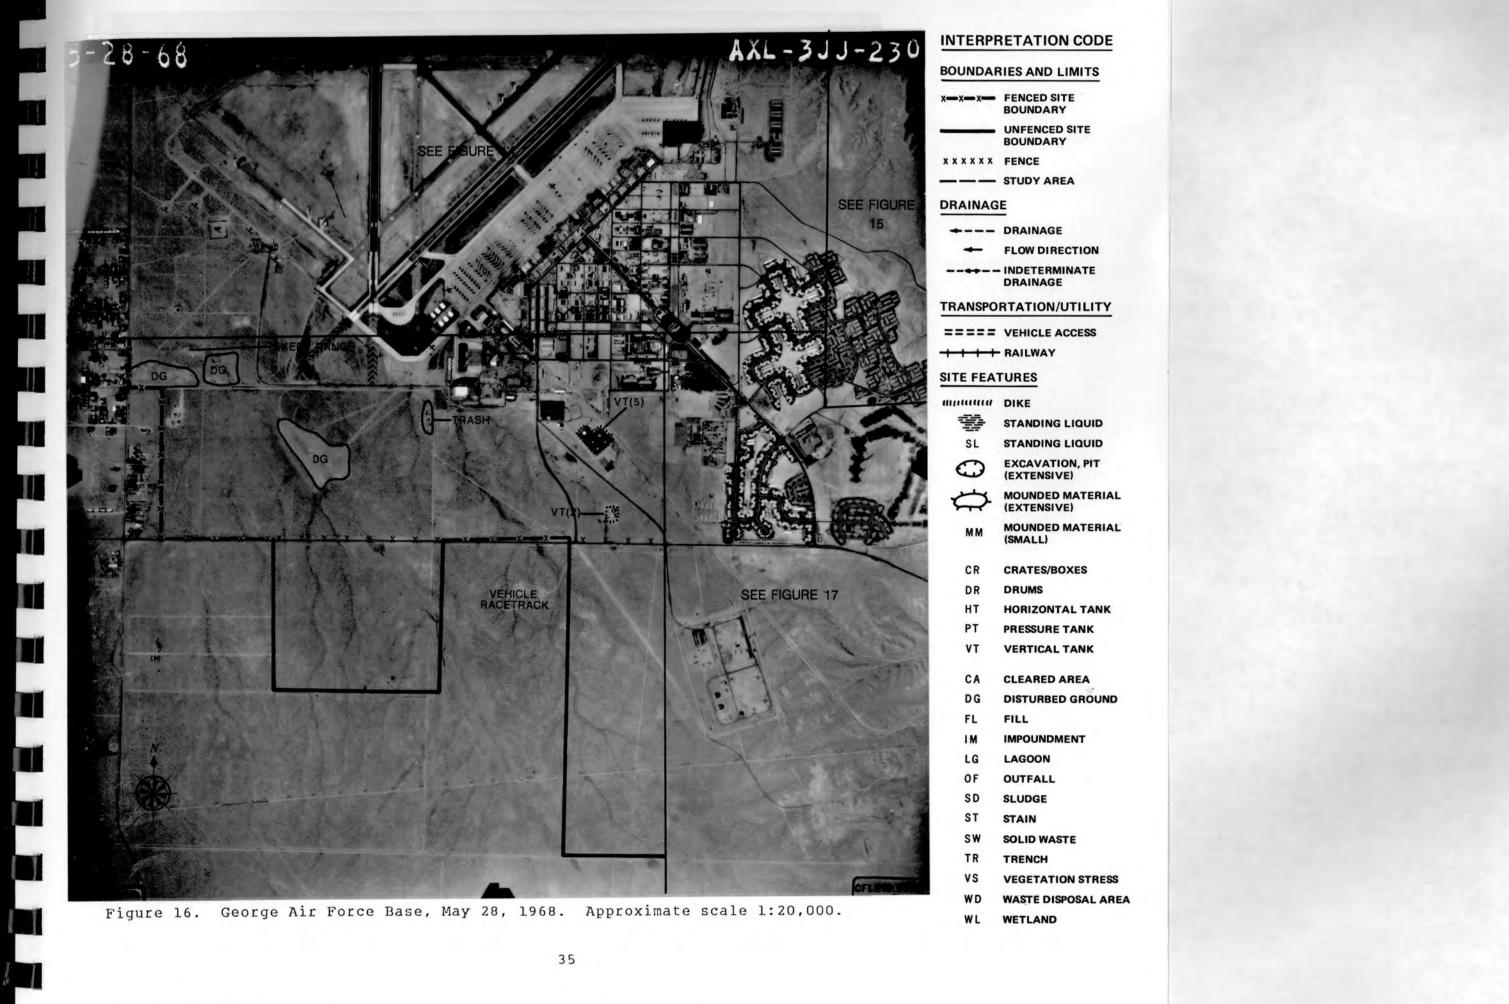
MAY 28, 1968 (FIGURE 16)

This photo shows the southwest portion of George Air Force Base. Three areas of disturbed ground are noted in the western portion of this area. The two smaller areas may be waste disposal sites. The larger, southernmost area's purpose is unknown. Poor photo quality precludes interpretation of activity within these areas. South of the main runways is an area where trash has been dumped.

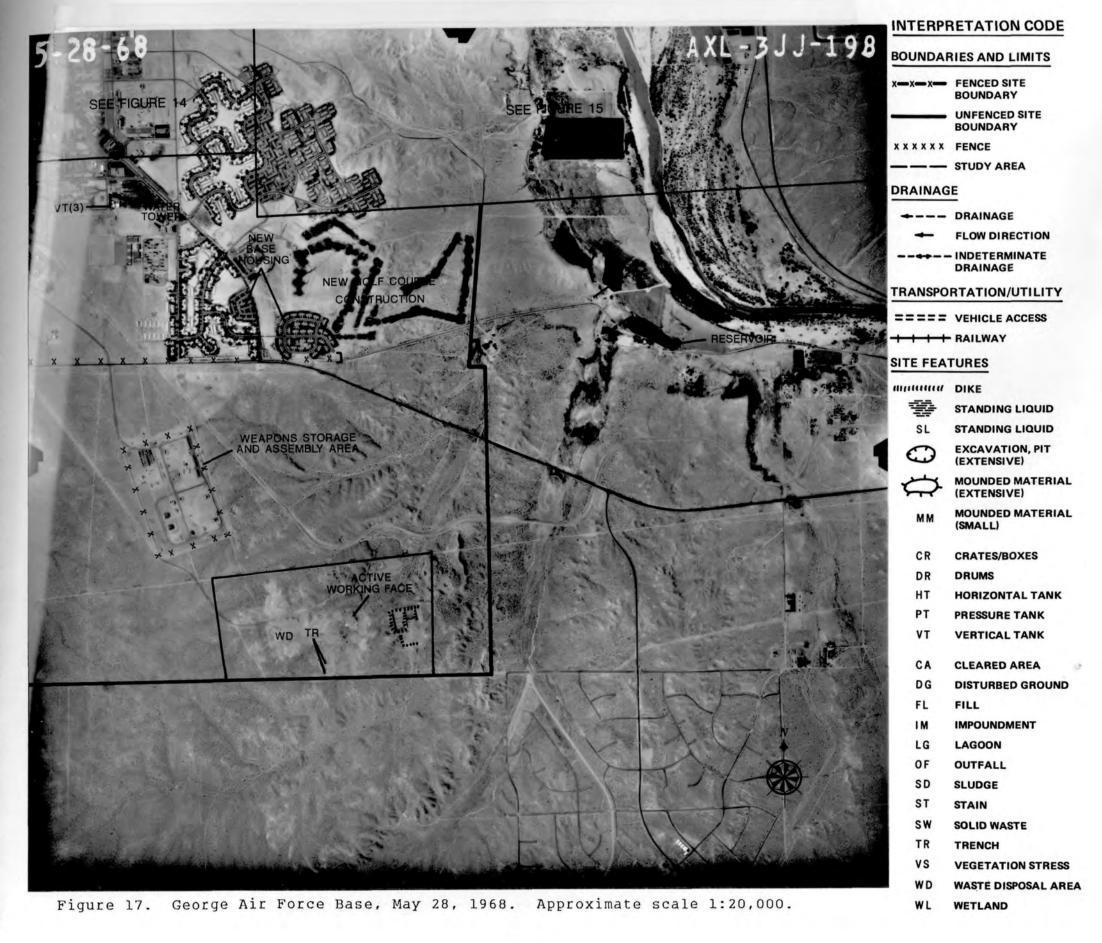
MAY 28, 1968 (FIGURE 17)

This photo shows the southeast portion of George Air Force Base. The only change noted since the 1959 photo coverage (Figure 12) has occurred in the waste dump area southeast of the weapons storage and assembly area. The numerous trenches, pits, and excavations noted in this area in 1959 have all been covered. Two new empty trenches are noted. The active working face of the waste dump is near the east-central portion of the area. East of the active portion of the dump is an area consisting of several earthen berms. The activity could not be identified in this area, but no waste materials were noted. The numerous dump-truck-size mounds of material noted in 1959 are no longer visible within the dump area. The poor quality of this photo may be obscuring their presence.

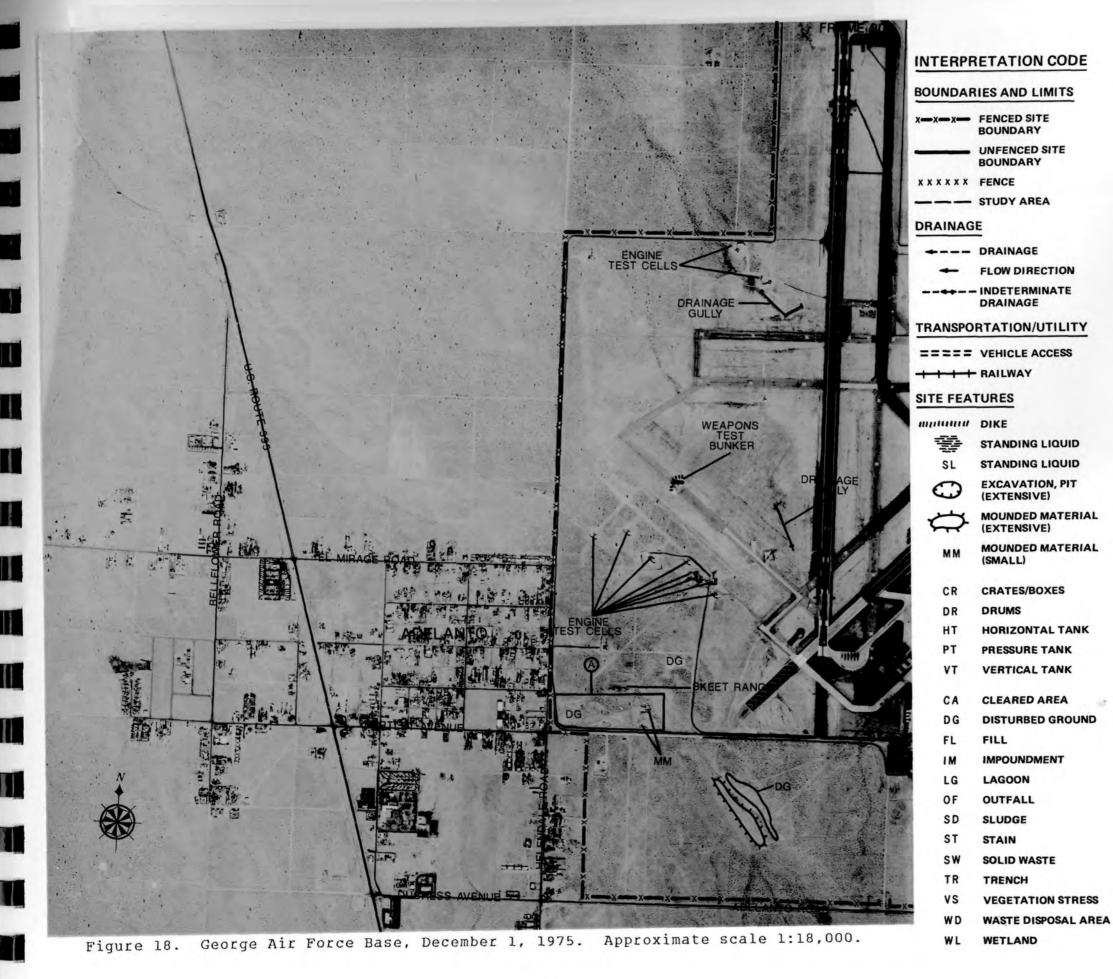
DECEMBER 1, 1975 (FIGURE 18)

Only a portion of George Air Force Base was covered on this year's photo coverage date. This photo shows the western portion of the base. There has been little change in this portion of the base since the 1968 photo coverage (Figures 14 and 16). The area at Annotation A appears to be a dump area. Two mounds of unidentified material are visible in the eastern portion of this area. Photo scale and quality precluded identification of the type of material. A mound is also noted southeast of Annotation A. The clean appearance of this mound suggests it might be fill material. No other changes are noted in this portion of the site.

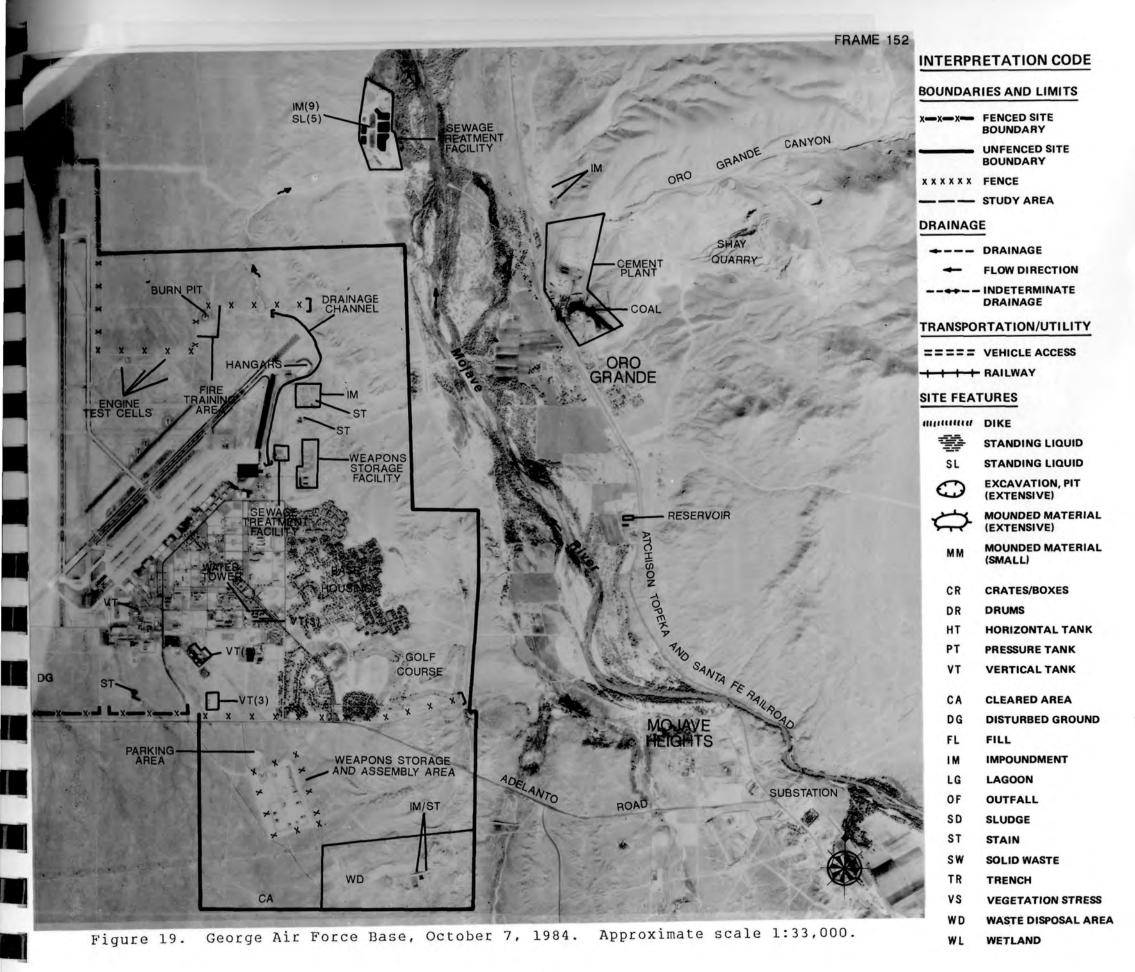
OCTOBER 7, 1984 (FIGURE 19)

This small scale photo shows all but the western portion of George Air Force Base. Due to the photographic scale, only a gross interpretation of features was possible. The changes noted since the 1968 photo coverage (Figures 14-17) are few. A new sewage treatment facility has been constructed northeast of the base, adjacent to the Mojave River. This facility has nine percolation ponds, five of these containing liquid waste. The old percolation ponds, situated on-base near the end of the northeast/southwest runways, are empty and appear abandoned. The on-base sewage treatment facility also appears inactive. The waste disposal area, southeast of the weapons storage and assembly area, does not appear active. The two unlined, possible impoundments, in the eastern portion of this area, are empty but have stained bottoms. No other environmentally significant items were detected.

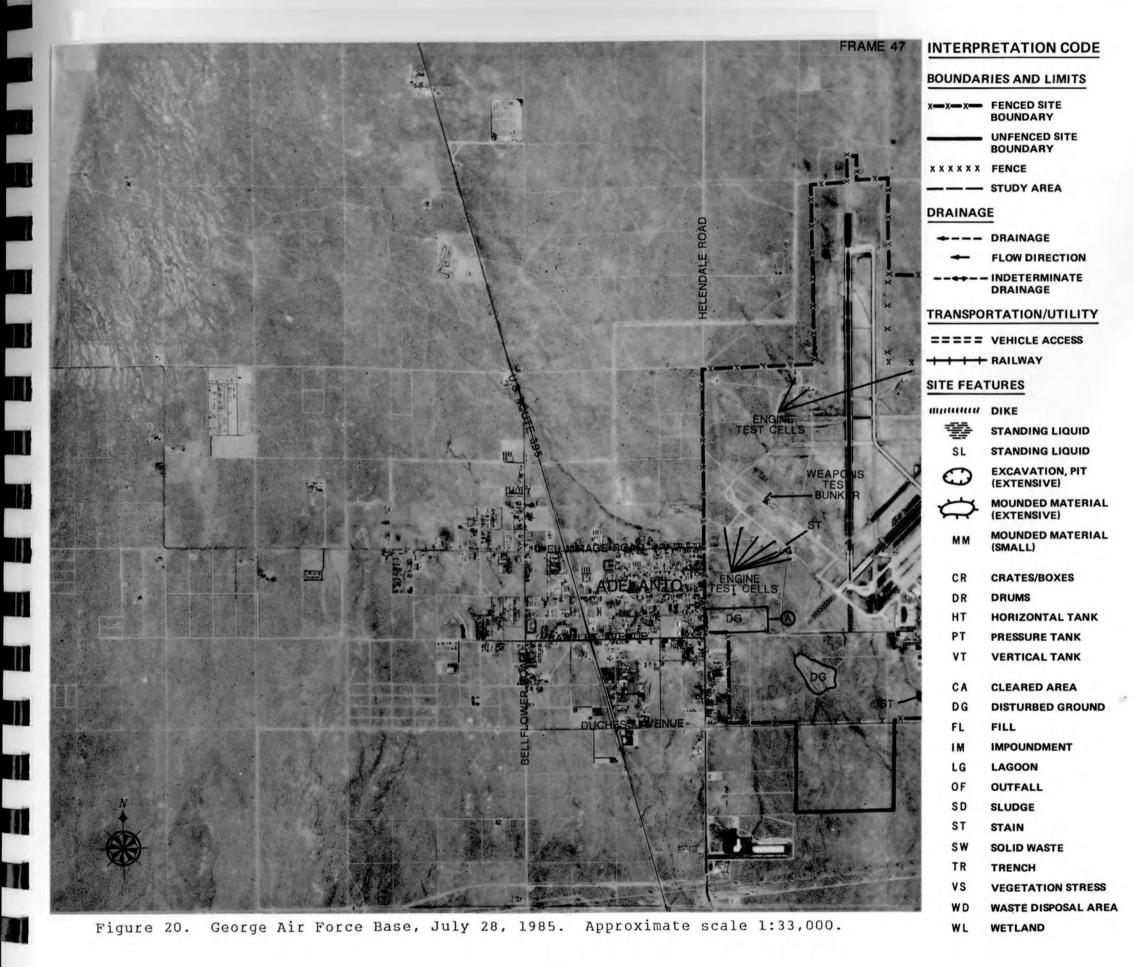
JULY 28, 1985 (FIGURE 20)

This photo shows the western portion of George Air Force Base. The eastern portion of the base was not covered on this date. See Figure 19 for 1984 coverage of the eastern portion of the base. Little change is visible to this portion of the site since the 1975 photo coverage (Figure 18). Annotation A still shows signs of unidentified activity due to the ground scarring visible, but it does not appear dumping is occurring in the area at this time. The disturbed ground noted southeast of Annotation A remains relatively unchanged, though the mounded material is not noted. The small scale of this photography again hampers detailed interpretation. Staining is noted south of the runways. Its source is unknown. Staining continues to be visible in aircraft parking and maintenance areas.

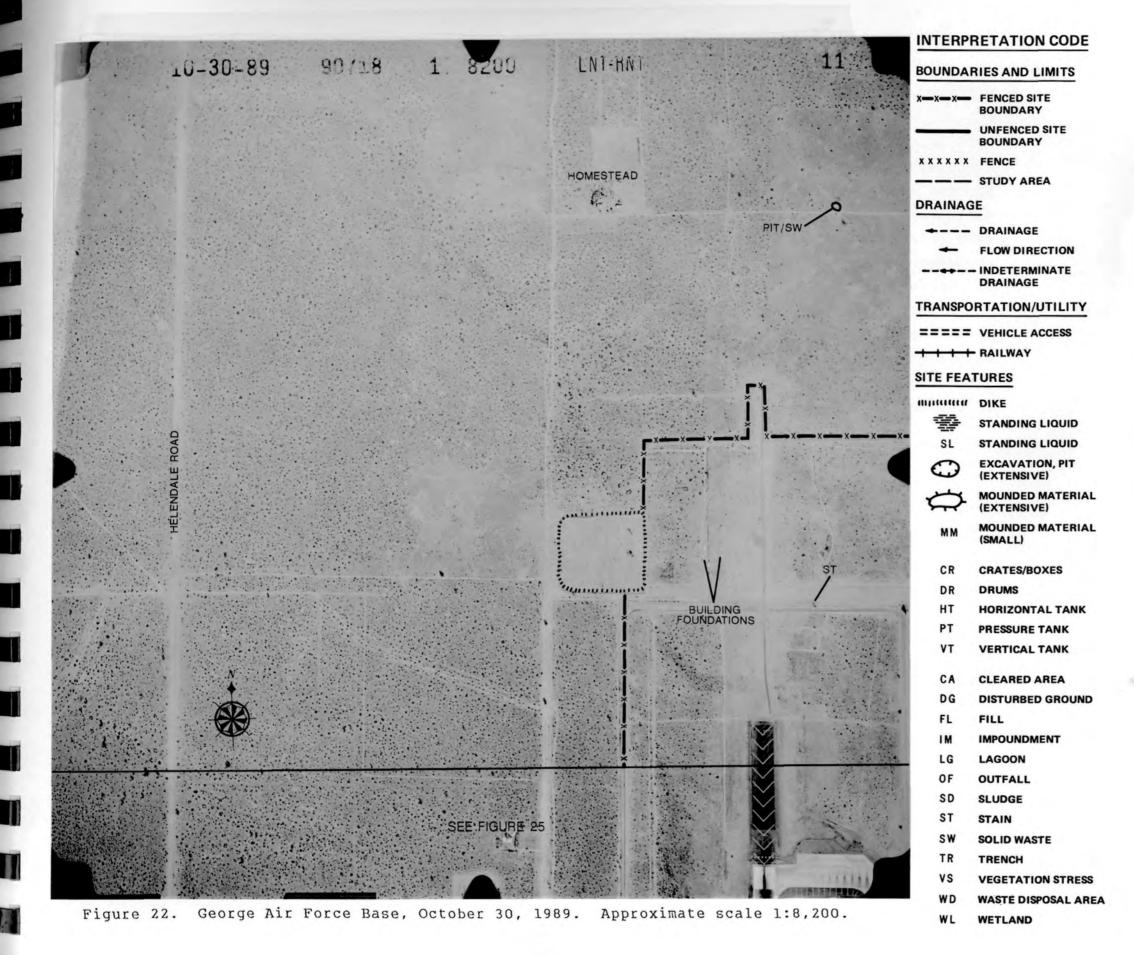
OCTOBER 30, 1989 (FIGURE 22)

This photo shows the extreme northwestern portion of George Air Force Base. The building foundations noted are those of the probable chicken farm noted in 1953 (Figure 3). East of the building foundations is a dark stain located just off the perimeter road. Source of the staining is unknown, though it appears to be indiscriminate dumping. A cleared, bermed area is noted outside the western perimeter fence. There is nothing within this area; the dark spots noted on the photo are trees and tree shadows. A shallow pit is noted, due north of the runway, off the site. Trash is noted in this pit, probably, again the result of indiscriminate dumping.

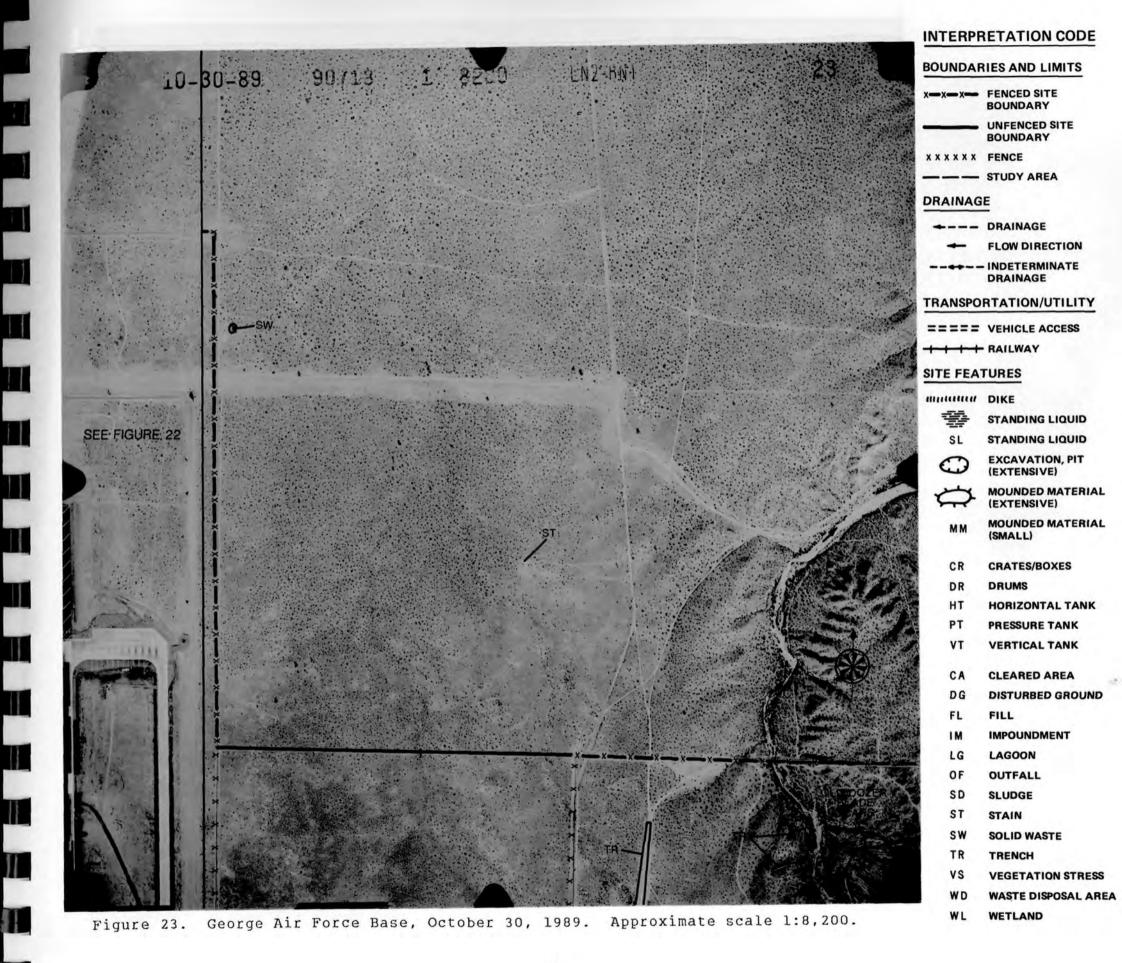
OCTOBER 30, 1989 (FIGURE 23)

This photo shows the north-central portion of George Air Force Base. Three trenches are noted within this portion of the base. These trenches are all empty. The two smaller trenches appear to be cuts made into the desert floor by a bulldozer. The larger trench terminates to the south, ending near the perimeter road (Figure 26). There is no disposal activity within this trench. East of these trenches is an area showing old, weathered bulldozer scars. This may have been an old borrow area. North of the trenches, outside the base perimeter, is a white-toned stain. The stain material appears to be either a white powder or a dried liquid. Its source is unknown. Vehicle tracks in the desert lead to and from this area to an improved dirt road to the east. Trash has been disposed of in a depression northwest of this stain, adjacent to the perimeter fence. The dark tone of the material suggests it may have been burned.
