Environmental Monitoring Systems Laboratory P.O. Box 93478 Las Vegas, NV 89193-3478 TS-PIC-90718 February 1990 Soms 88188004

AERIAL PHOTOGRAPHIC ANALYSIS OF GEORGE AIR FORCE BASE

Victorville, California

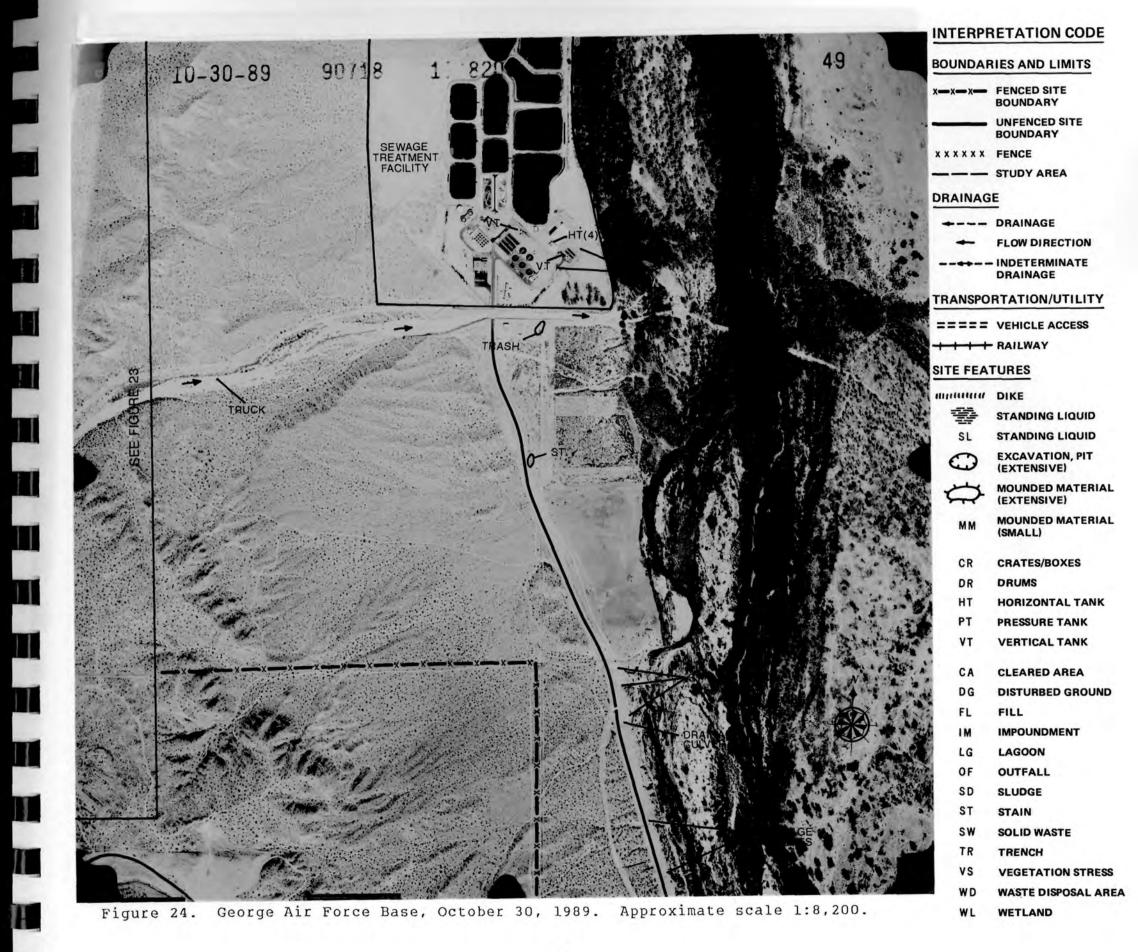
OCTOBER 30, 1989 (FIGURE 24)

This photo shows the northeastern portion of George Air Force Base. There are no environmentally significant items in this portion of the air base. White-toned stains are noted north and east of the base, along the road to the sewage treatment facility. It appears that a liquid has been dumped down the slope off the side of the road. These may also be just alkali stains from water runoff through the culverts. A small mound of trash is noted outside the south end of the treatment facility.

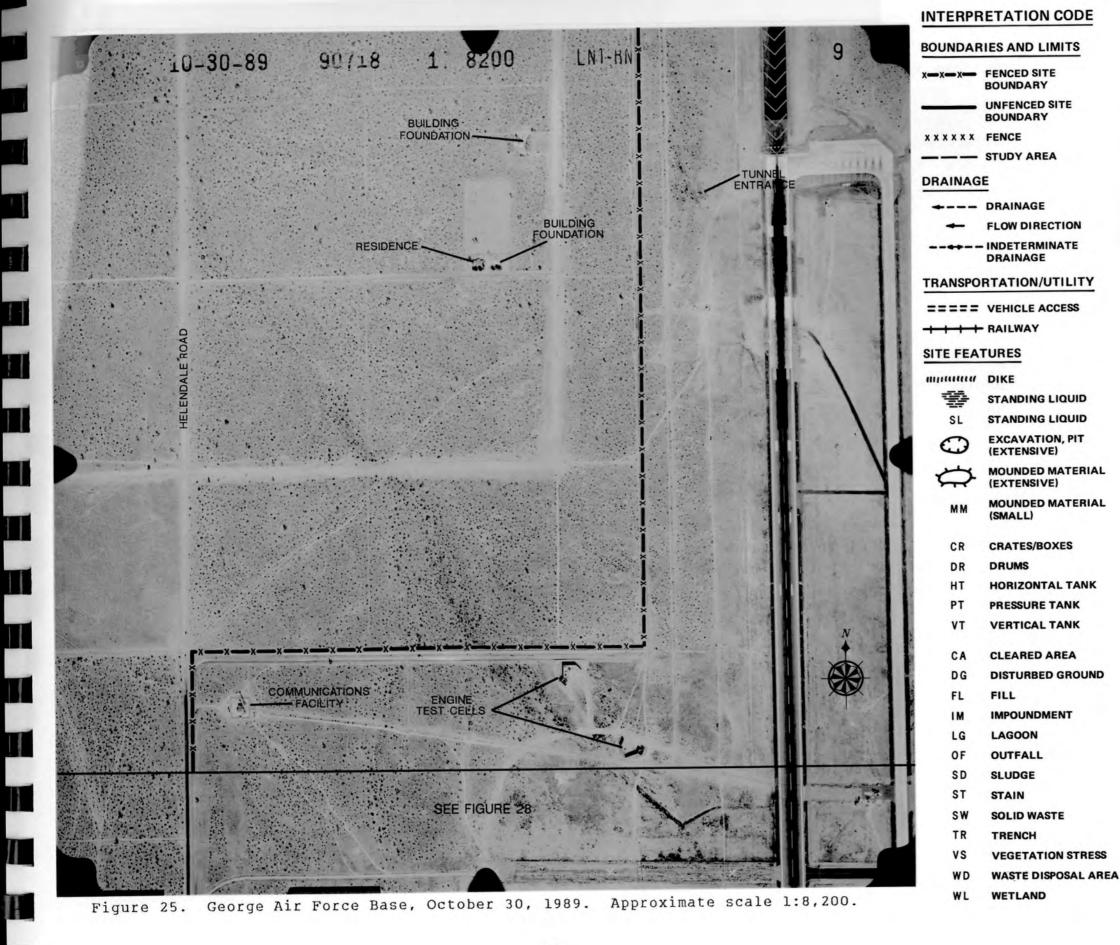
OCTOBER 30, 1989 (FIGURE 25)

This photo shows the west-central portion of George Air Force Base. Visible are two engine test cells which no longer appear to be in use. No environmentally significant items were noted in this portion of the site.

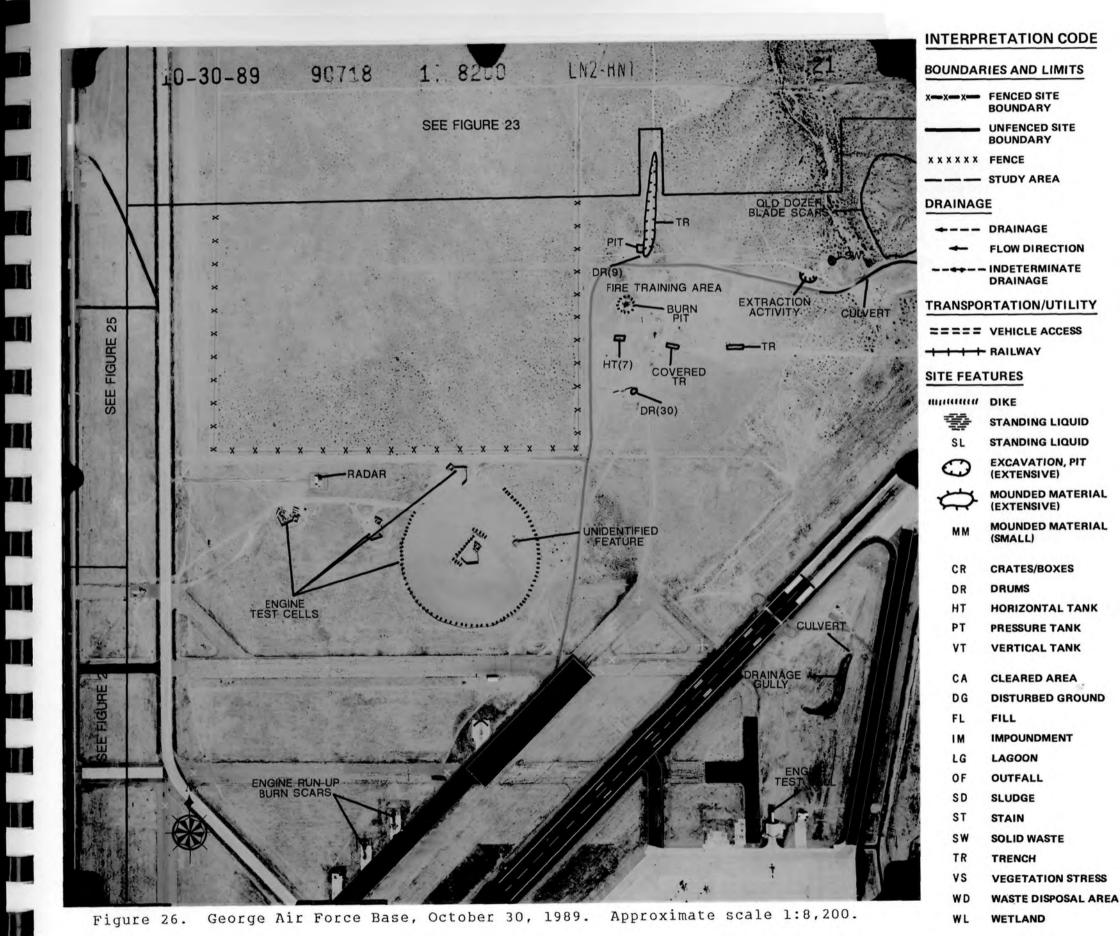
OCTOBER 30, 1989 (FIGURE 26)

This photo shows a central portion of George Air Force Base. A long trench with a square pit at its south end is noted north of the fire training area. A square concrete structure is visible within the pit. Its purpose is unknown. The trench is empty and does not appear to be waste related. Nine drums are noted adjacent to the pit. Thirty drums, seven horizontal tanks, two trenches and a burn pit are noted in the fire training area. One of the trenches has been covered with fill, while the other is empty. These trenches do not appear to be waste related. The fire training area appears clean and well maintained. East of this area is an area of extraction activity and a small pile of solid waste. The waste material appears to be burn residue. An area of old bulldozer blade scarring is noted further to the east. Four engine test cells are noted near the center of the photo. The purpose of a low berm surrounding one of these is unknown. An unidentified feature is noted within the bermed area.

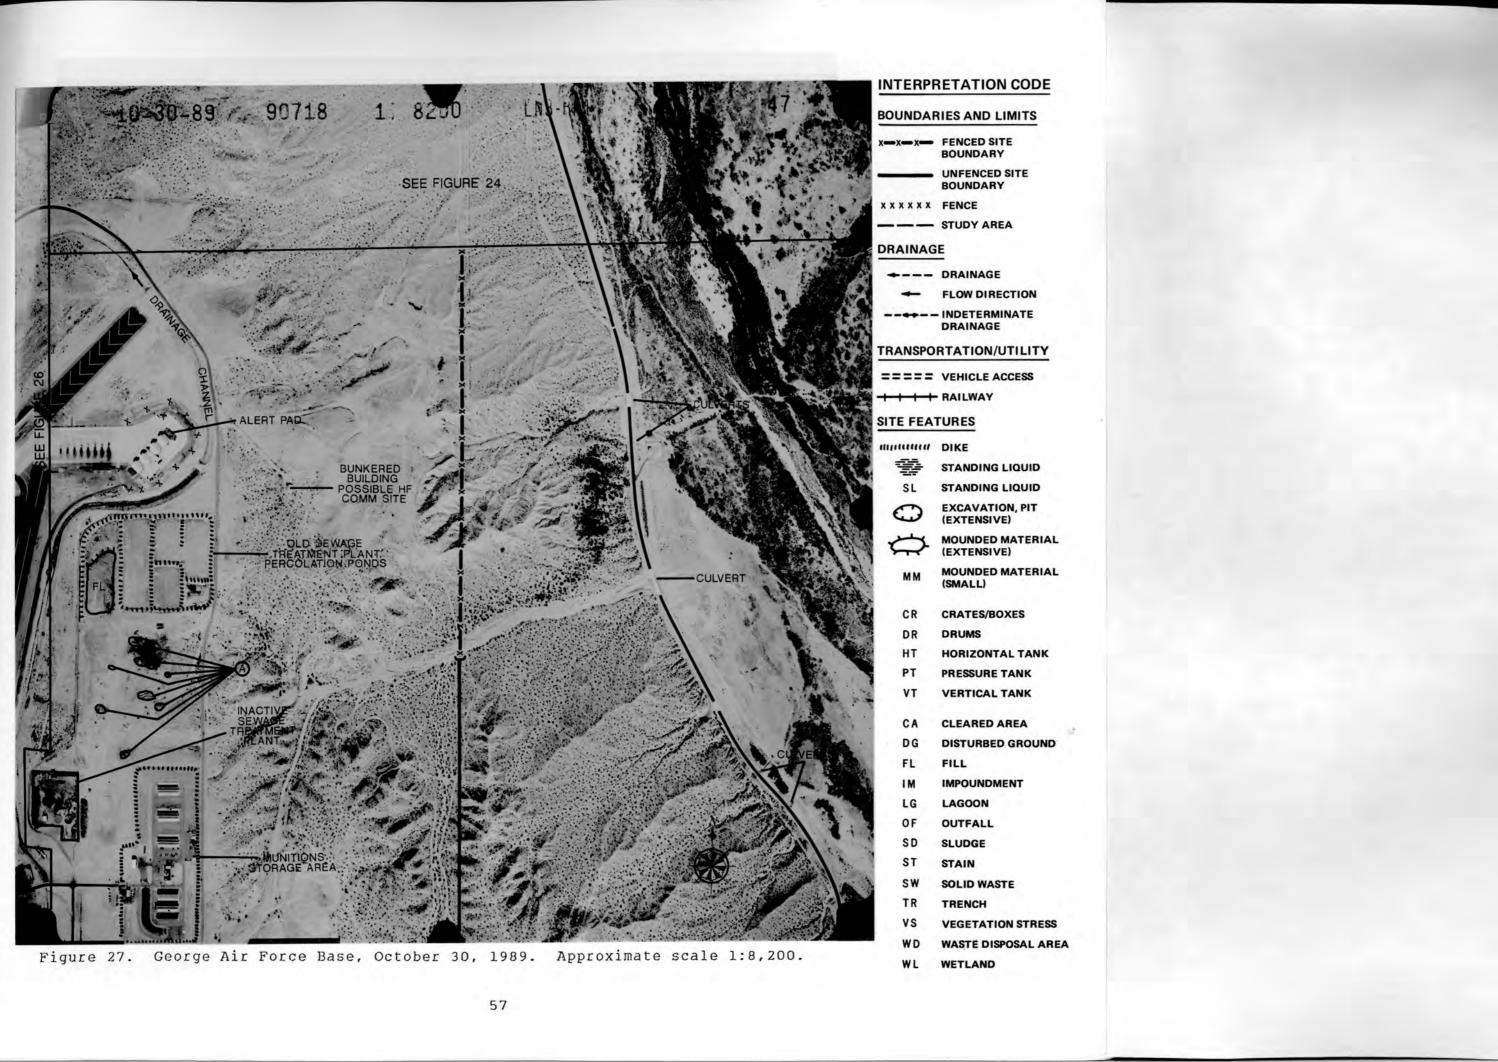
OCTOBER 30, 1989 (FIGURE 27)

This photo shows the east-central portion of George Air Force Base. The old sewage treatment facility's percolation ponds have been emptied and cleaned. The westernmost pond, which was not present on the 1984 photo (Figure 19) is being filled. The material being used as filler is of various colors and is unidentifiable. It is possibly a mixture of soil and waste material. Several mounds of multi-hued, unidentified material (Annotation A) are visible south of the ponds.

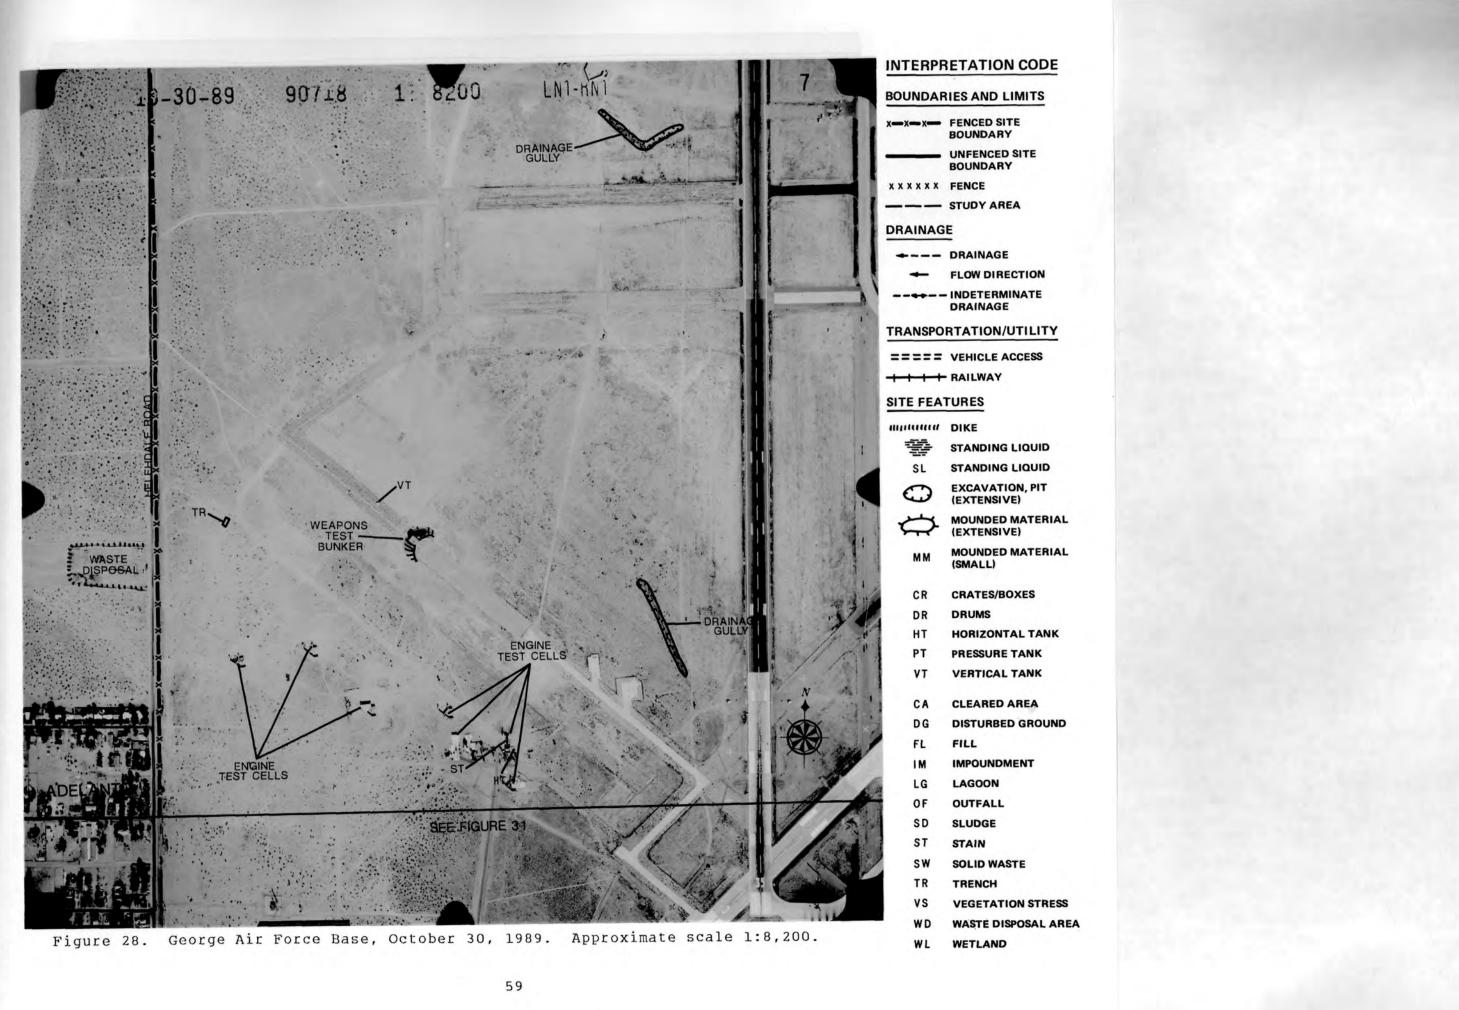
OCTOBER 30, 1989 (FIGURE 28)

This photo shows a west-central portion of George Air Force Base. There has been little change in this portion of the site since the 1985 photo coverage (Figure 20). A small trench is noted west of the weapons test bunker. The trench is empty and is probably not waste related. An area of waste disposal is noted outside the western perimeter fence, north of the town of Adelanto. The material appears to be municipal trash. A trench was noted in this area in 1953 (Figure 3).

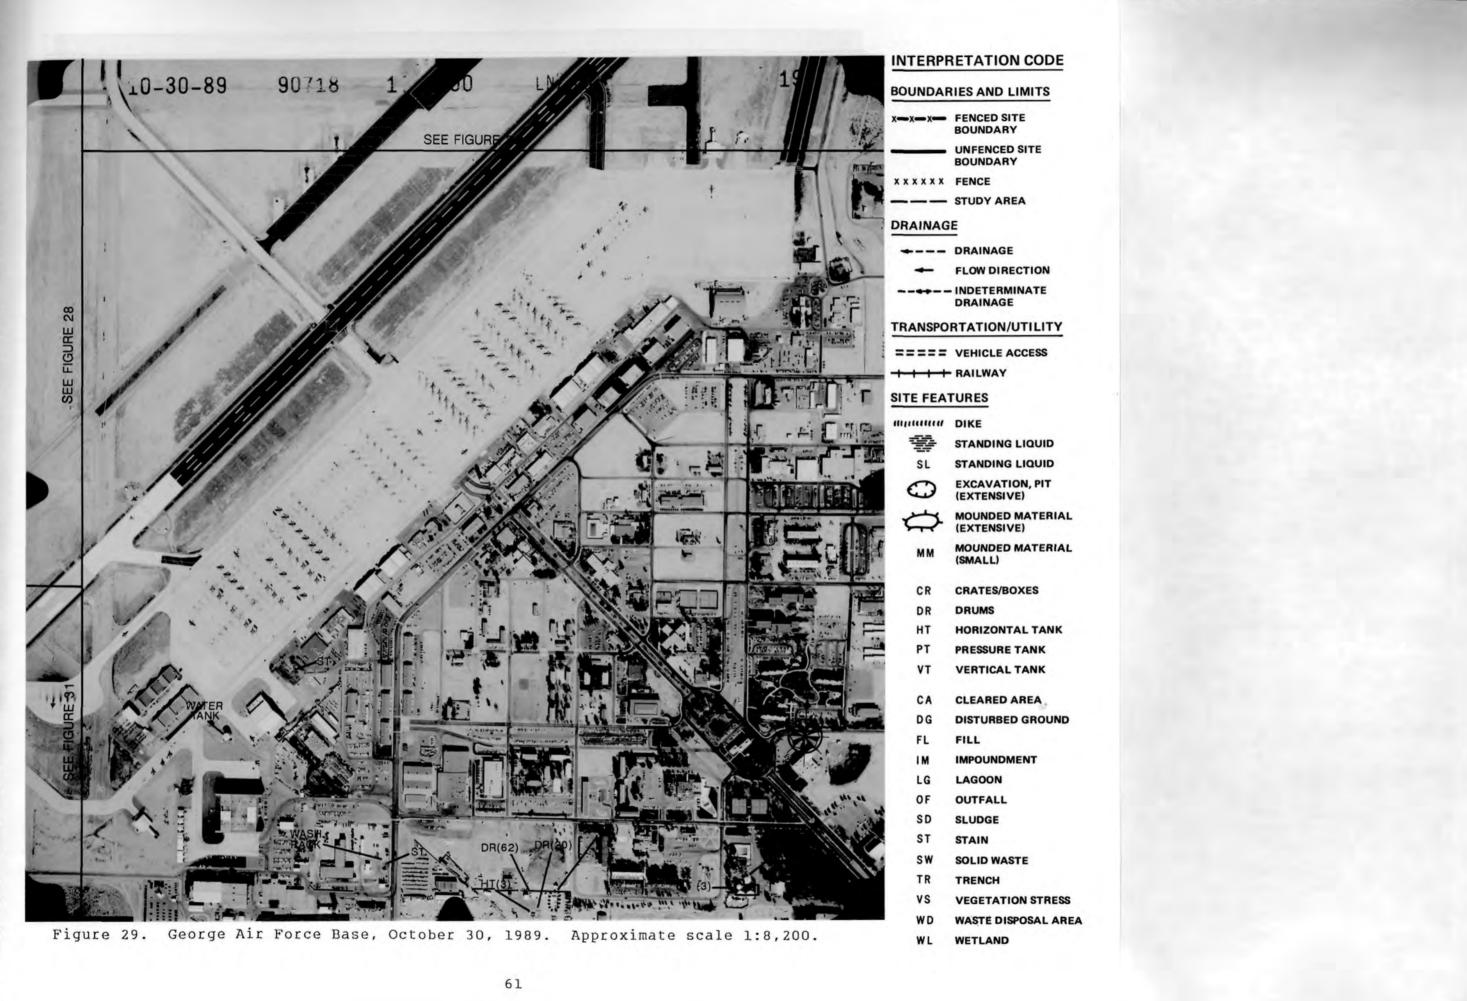
OCTOBER 30, 1989 (FIGURE 29)

This photo sows a central portion of George Air Force Base. A dark stain is noted near a maintenance building adjacent to the parking apron. Another stain is noted at a wash rack in the motor pool area to the south. The three-bay wash rack appears to have a center drain. Numerous stains are noted on the parking apron itself, the result of aircraft run-up operations. Approximately 167 drums are noted in a storage yard near the bottom of the photo. Three vertical and three horizontal tanks are also noted.

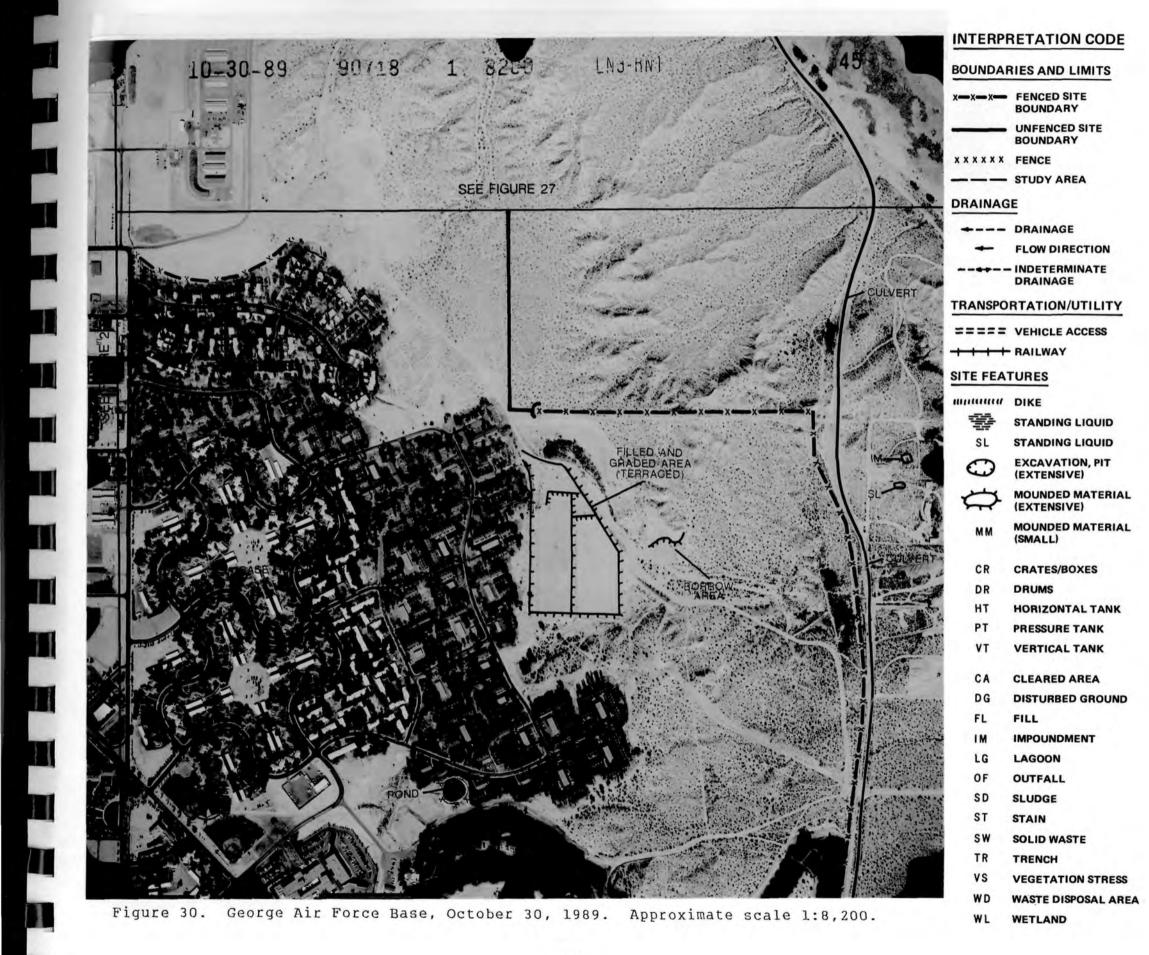
OCTOBER 30, 1989 (FIGURE 30)

This photo shows an east-central portion of George Air Force Base. The area covers the base housing area and a small portion of the base golf course. The fill and graded area on the eastern fringe of the housing area is the same area on which a waste dump was noted in 1959 (Figure 11). A borrow area is noted east of this area.

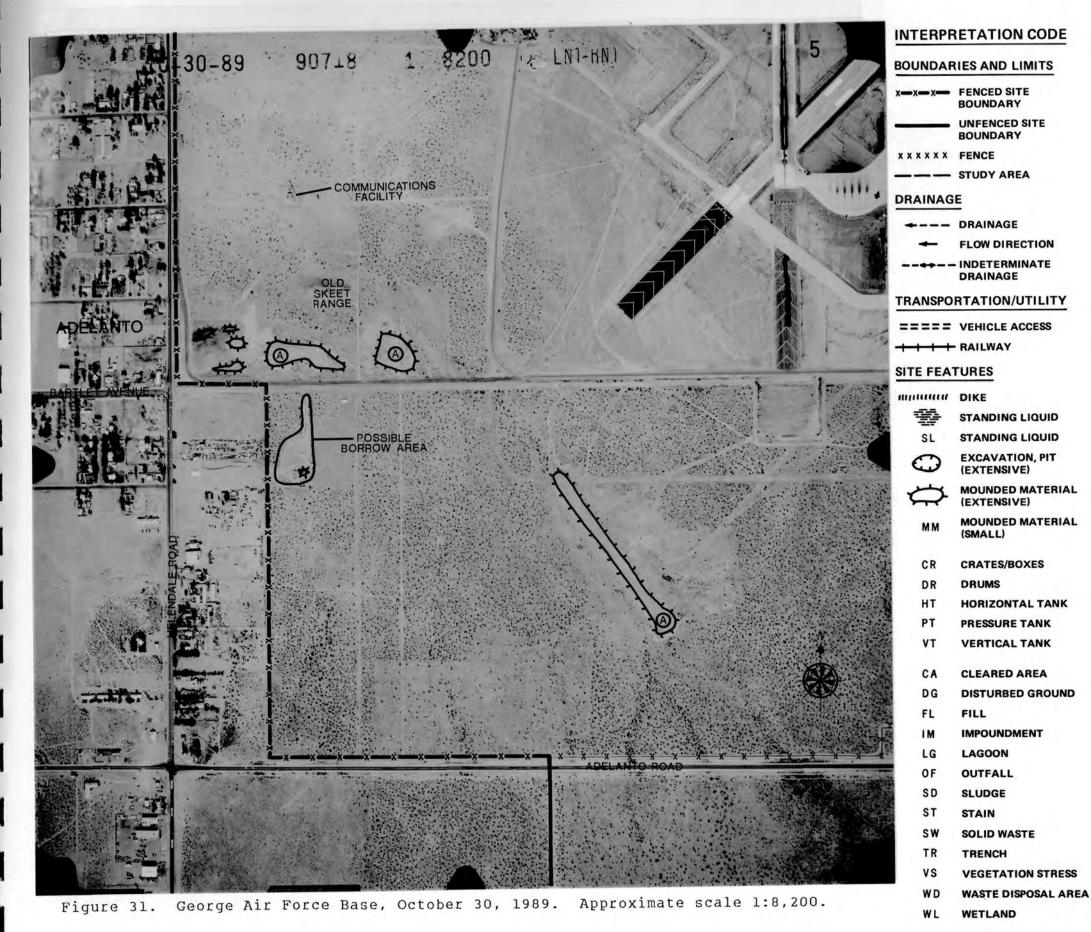
OCTOBER 30, 1989 (FIGURE 31)

This photo shows the southwestern portion of George Air Force Base. Annotations A are three areas of mounded material. Ground disturbances have been noted in the area of the two northernmost mounds as early as 1953 (Figure 5), and the southern mound since 1968 (Figure 16). It has been reported that these areas were once used as disposal areas for construction rubble. Prior years of photography did not permit the identification of materials supposedly dumped in these areas due to photographic scale and quality. Smaller unidentified mounds of material are noted west of the northernmost mounds.

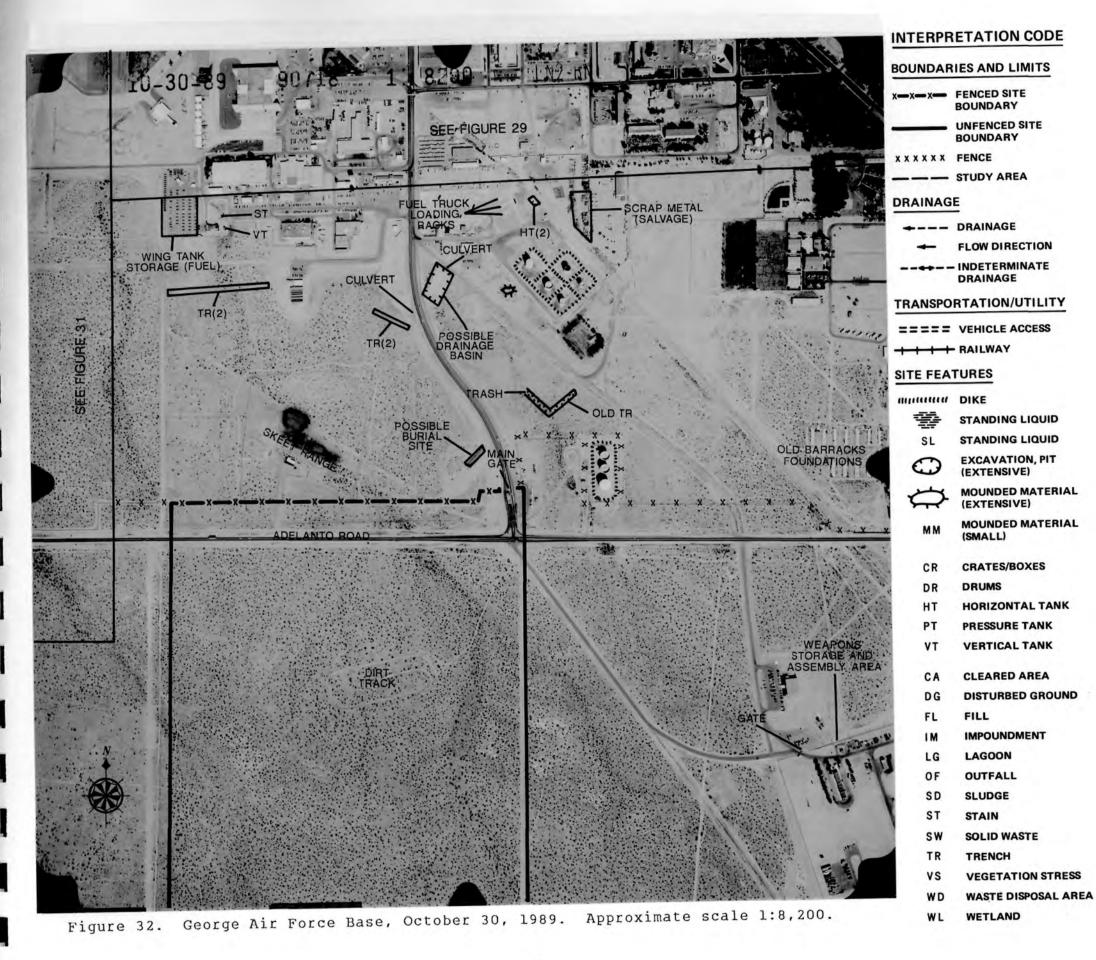
OCTOBER 30, 1989 (FIGURE 32)

This photo shows the central portion of George Air Force Base. Four empty trenches are noted. These trenches do not appear to be waste related. A V-shaped trench is noted near the center of the photo. Trash is visible in the northwest end of this trench. A possible burial site is noted just northwest of the main gate. A medium and a light gray material has been spread over an area of the desert floor. This may be a cover material. Salvageable scrap metal is noted in a storage yard, which is probably the marketing/redistribution facility.

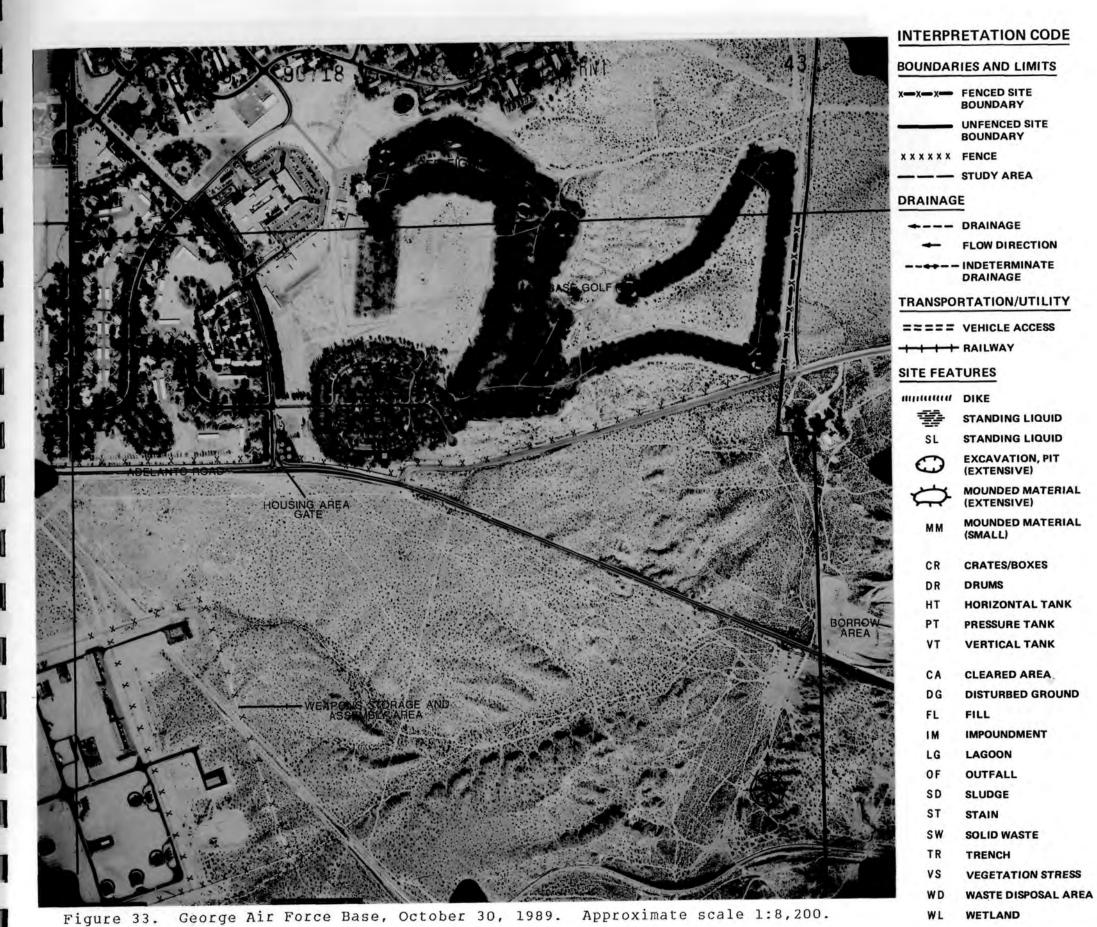
OCTOBER 30, 1989 (FIGURE 33)

This photo shows the southeast portion of George Air Force Base. There are no environmentally significant items noted on this photo. Annotations A are explosive storage bunkers.

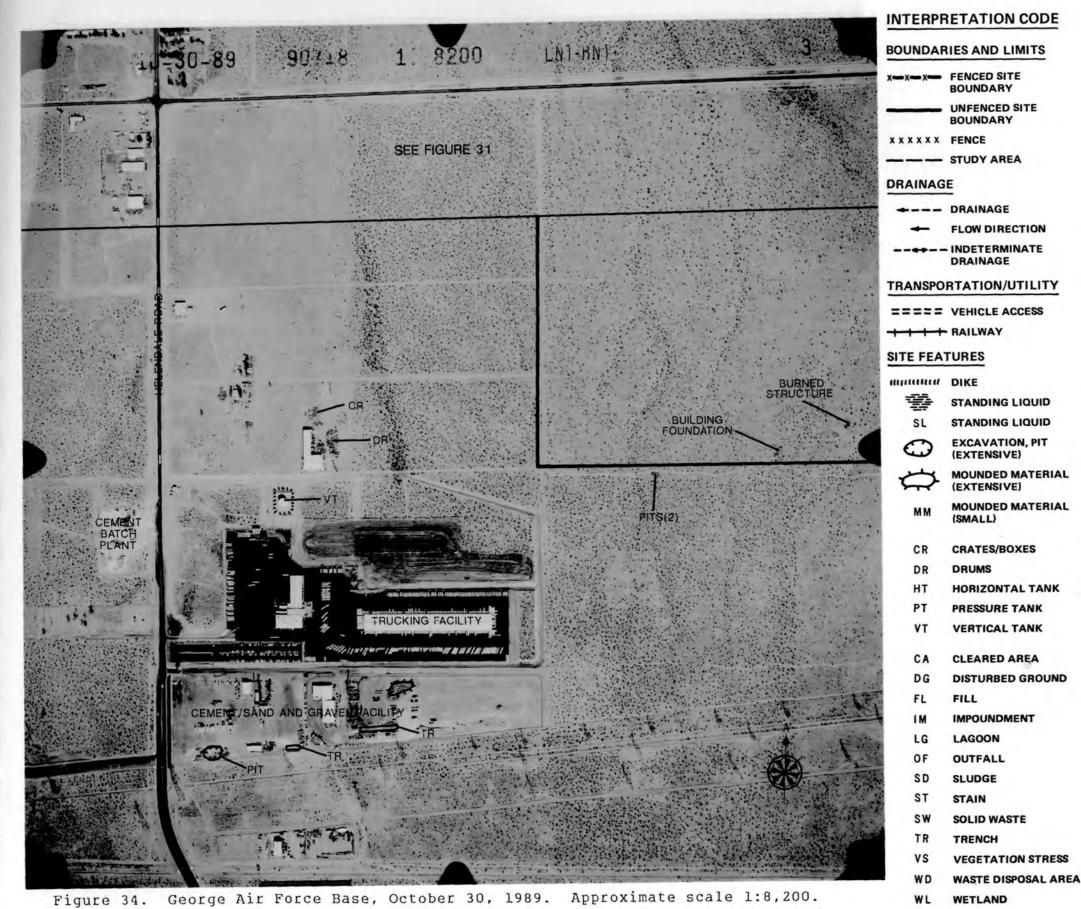
OCT'OBER 30, 1989 (FIGURE 34)

This photo shows the extreme southwest corner of George Air Force Base. A burned structure and an old building foundation are noted in this portion of the site. Two circular pits are noted just outside the base perimeter. These pits have the appearance of old bomb craters. A trucking facility with one well-contained vertical tank, a cement/sand and gravel facility, and a cement batch plant are also noted. Two trenches and a pit are noted in the cement/sand and gravel facility. North of these facilities is an unidentified facility with drums and crates visible.

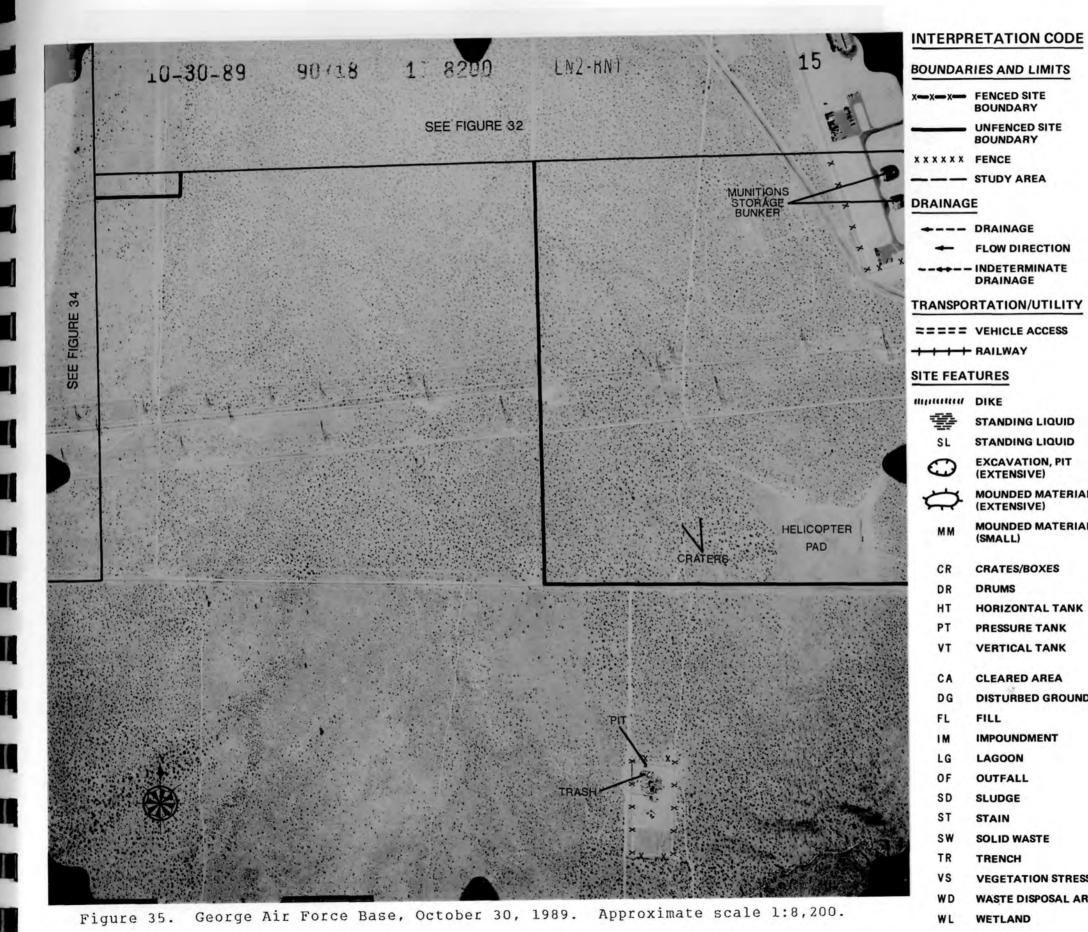
OCTOBER 30, 1989 (FIGURE 35)

This photo shows the extreme south-central portion of George Air Force Base. A small unidentified facility, outside the southern perimeter of the base, has an empty pit and a pile of trash visible. Two shallow pits, possibly bomb craters are also noted. No other significant items are noted.

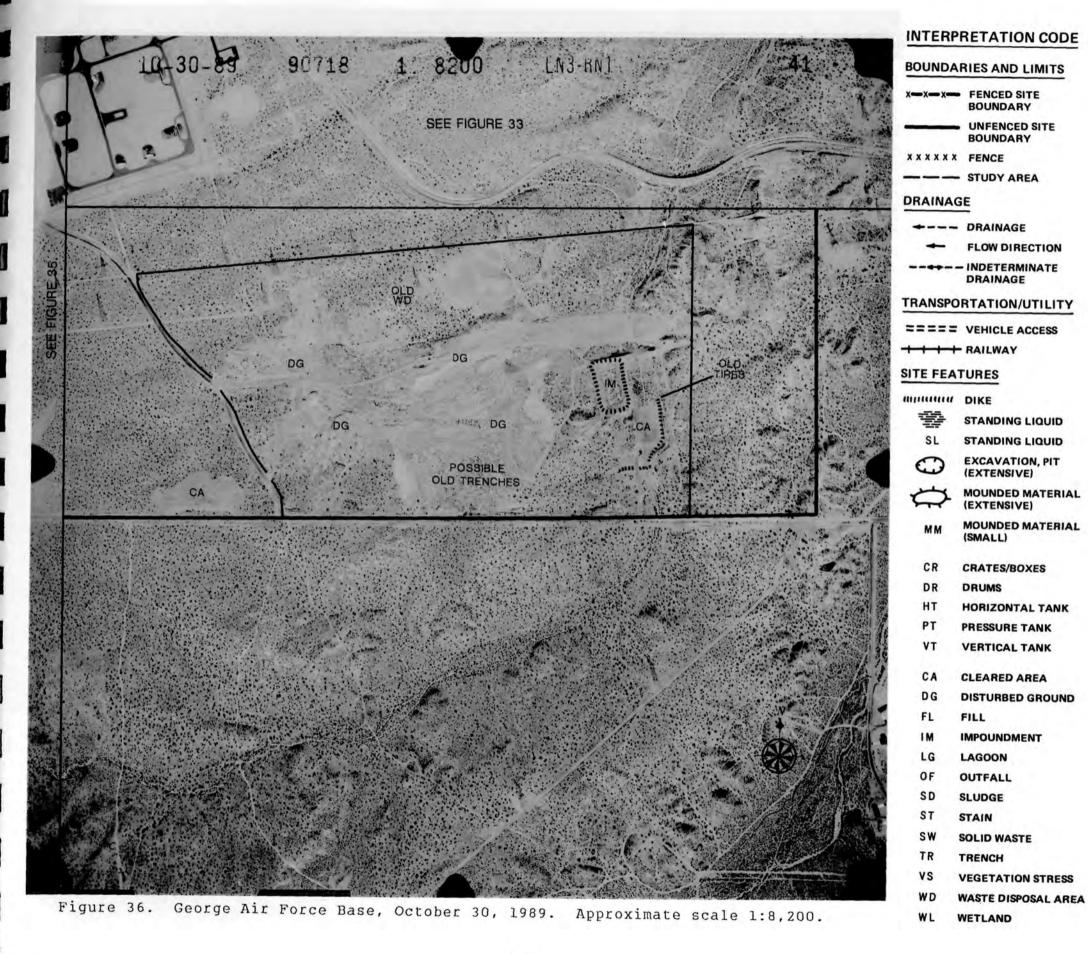
OCTOBER 30, 1989 (FIGURE 36)

This photo shows the extreme southeast portion of George Air Force Base. The old waste dump noted no longer appears to be active. Considerable ground scarring is visible within the area. The scarring appears to have been caused by bulldozer activity. The only visible waste in the area is a pile of old tires at the east end of the dump. The impoundment noted is empty and does not appear to have been in use for some time. Desert shrubs cover the floor of the impoundment. No other items of significance are noted.
